TO: Owners and Operators of Yankee Aircraft

SUBJECT: Main Landing Gear Bracket Inspection

MODELS AFFECTED: AAL-0002 thru AAL-0008, AAL-0011 thru AAL-0014

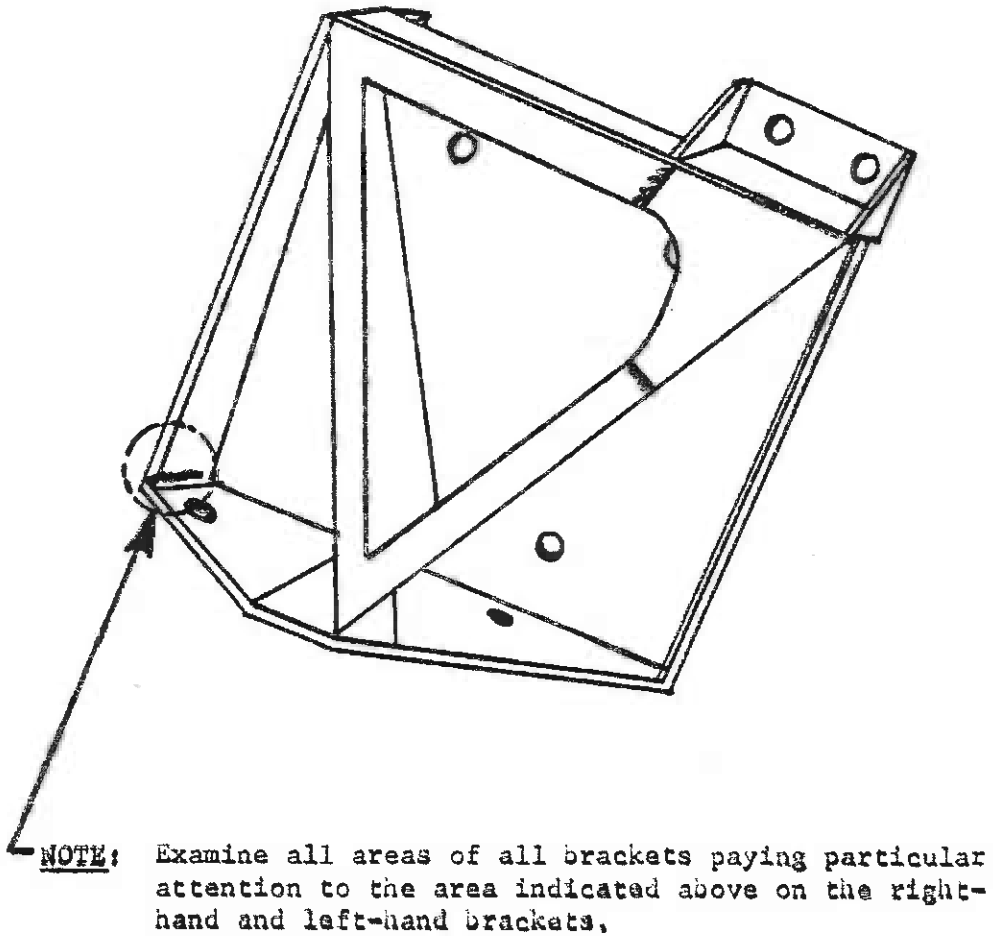
Figure 1. Right-Hand Main Landing Gear Bracket

Field reports indicate that upper main landing gear brackets installed on above aircraft may be subject to cracking in the area of the welded joints. To confirm the structural integrity of brackets installed on these aircraft, the following must be accomplished within 25 hours of operation and at each subsequent 100 hour inspection.

NOTE: The upper main landing gear brackets are heat treated and if cracks or damage are found, DO NOT WELD. The brackets must be replaced.

1. Visually inspect upper main landing gear welded brackets for evidence of cracks.
2. Complete the enclosed Service Reply Card showing compliance with this bulletin and showing aircraft hours and forward card to American Aviation Corporation.
3. Complete a log book entry indicating compliance with this bulletin.

Service Kit No. SK-108 (Main Landing Gear Modification) has been developed to assist in changing brackets in the field. Service Kit No. SK-108 includes new brackets and all hardware and instructions for field retrofit of both the right and left upper gear brackets. This kit must be installed on all aircraft on which cracked brackets are found. Brackets removed from affected aircraft must be returned to the factory.
