DATE: March 8, 1972

SUBJECT: Flap Motor/Right Rudder Cable Clearance Inspection

SERIALS AFFECTED: All Model AA-1 and AA-1A Aircraft

TIME OF COMPLIANCE: At each scheduled inspection or at any time the flap actuator is removed

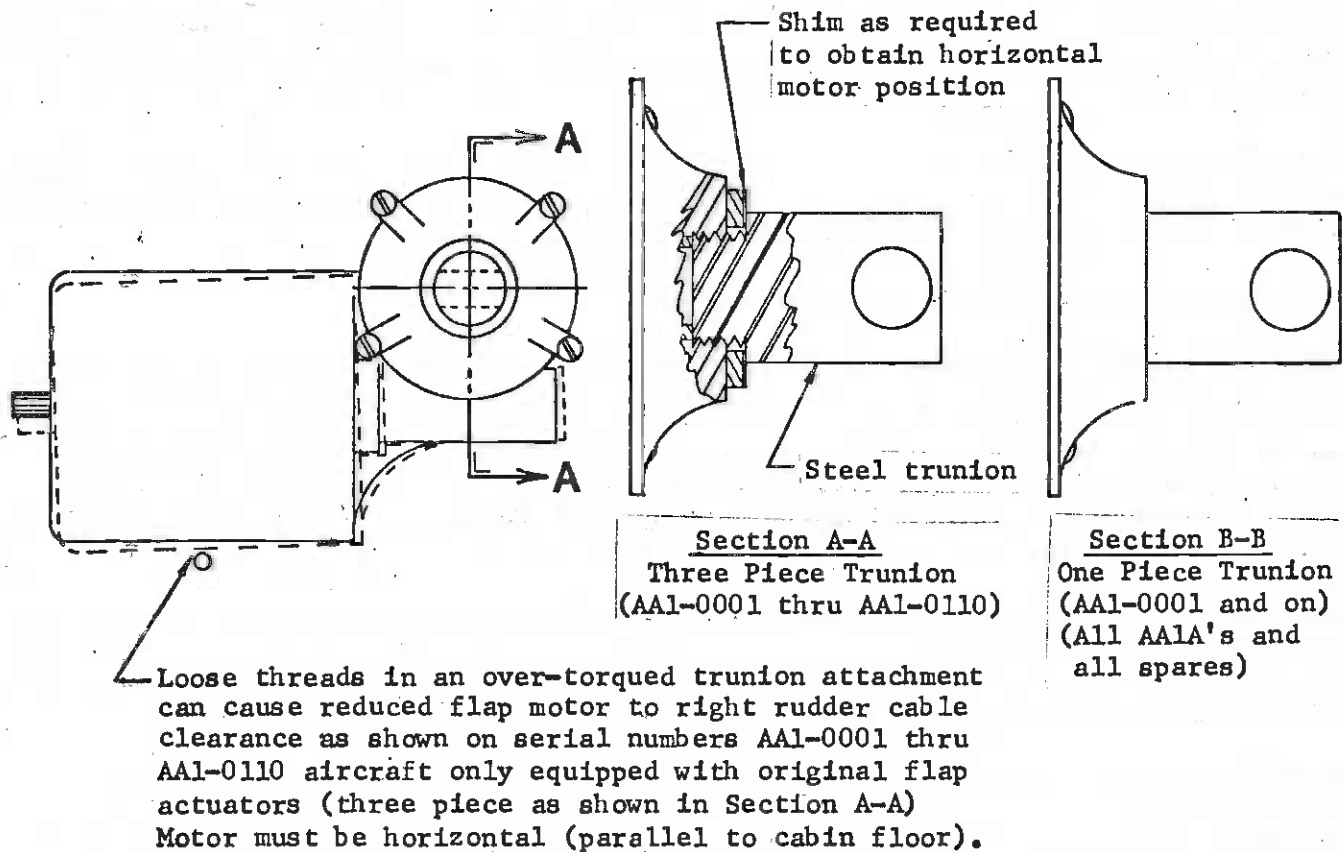
FIGURE 1
FLAP TRUNION MOUNT DETAILS

On AA-1 aircraft, serial numbers AAL-0001 through AAL-0110, the actuator end cap is a three (3) piece assembly, utilizing a threaded steel trunion which is screwed into the end cap (see Figure 1). These units should be checked to verify that the steel trunion fitting is secure in the end cap and that it has not been overtightened, causing the motor housing to be rotated down closer to the cables, thereby reducing cable clearance. In the event that it had been overtightened, it can be adjusted by shimming, to position the flap motor parallel to the floor (see Figure 1).

When the correct shimming has been determined, reinstall the trunion using stud lock grade Loctite on the threads to prevent loosening in service. This three (3) piece end cap assembly may be replaced with the newer design one piece end cap, part number G5011-1B mentioned above, any time replacement is necessary.

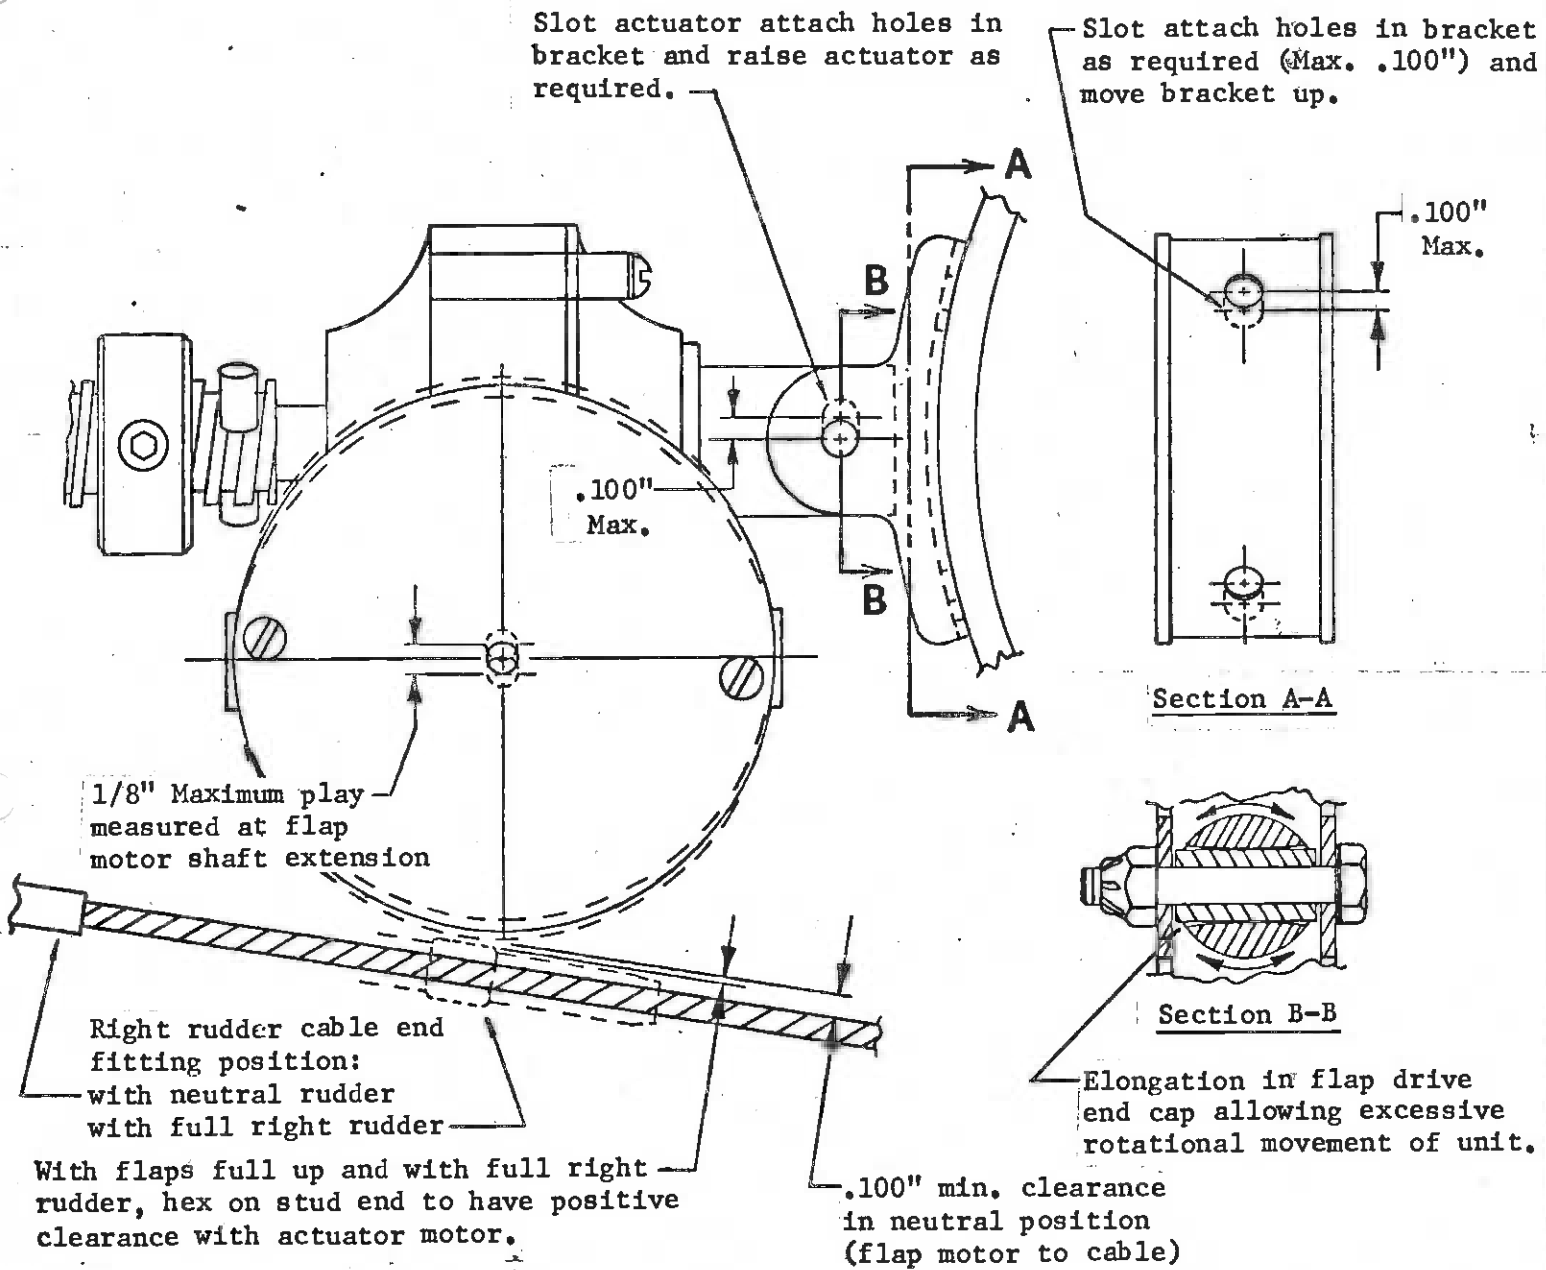
FIGURE 2
FLAP MOTOR/RUDDER CABLE CLEARANCE
INSPECTION AND BRACKET MODIFICATION
INSTRUCTIONS

Field reports indicate that on some aircraft the right rudder cable may be rubbing the bottom of the flap motor housing.

At each scheduled inspection and any time the flap actuator is removed, check that all attaching bolts on the flap motor drive unit mounting bracket are tight. Minimum clearance between the right rudder cable and the flap motor housing should be .100" with the rudder in neutral position and positive clearance with full right rudder (see Figure 2). If the clearance is less than .100", check for looseness or wear in the actuator forward attach hole by moving the flap motor housing up and down and measuring the movement at the motor shaft extension centerline (see Figure 2). If this movement exceeds 1/8" and the movement is caused by an elongated hole in the actuator end cap, then this end cap must be replaced. This cap is available from the Customer Service Department at American Aviation Corporation, under part number G5011-1B at \$3.00 (E) each.

If the movement is less than 1/8" and the cable clearance is less than .100", then the actuator attach bracket holes may be slotted per Figure 2, as required, to raise the actuator up and obtain the required rudder cable clearance.

If, with a correctly installed trunion, the cable clearance is still less than specified above, the actuator attach bracket holes may be slotted per Figure 2, as required, allowing the unit to be raised up, to obtain the correct cable clearance.

Do not raise actuator more than required to obtain desired cable clearance as interference between the motor housing and console/right seat track can occur.

- Step 1 - Slot bracket holes as necessary per Sect. A-A.
- Step 2 - Slot bracket holes (.100" Max.) at trunion mount if more clearance is required than obtained with maximum Section A-A slotting.
