SERVICE BULLETIN NO. 132

DATE: September 19, 1972
SUBJECT: Additional Aileron Drain Holes
SERIALS AFFECTED: AA5-0001 through AA5-0159
TIME OF COMPLIANCE: Before further flight in heavy rain but not later than the next scheduled inspection.

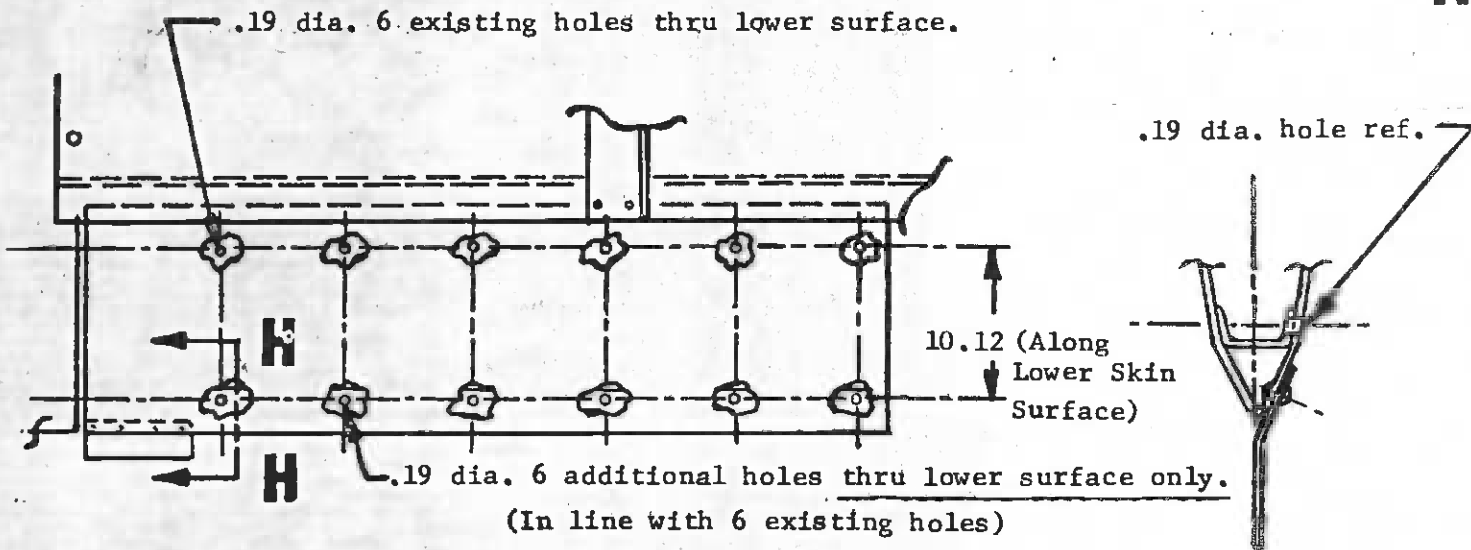
On aircraft AA5-0160 and on, additional drain holes have been incorporated on the bottom surfaces of the ailerons to provide water drainage with the ailerons in the down position and increased drainage during flight in heavy rain. Existing holes provide drainage with the ailerons in the neutral position only. To preclude the possibility of a water becoming trapped, freezing and causing structural damage to the aileron and to prevent any accumulation of water inside the aileron when flying through heavy rain, the additional drain holes must be added as shown in Figure 1.

Figure 1. Additional Aileron Drain Hole Locations.
View- Top of LH Aileron Looking Down.
