SERVICE BULLETIN NO. 133
(Supersedes Wire Bulletin No. 133,
dated October 13, 1972)

DATE: October 16, 1972

SUBJECT: Fuel Pressure Lines Inspection

MODELS AFFECTED: All AA-1 and AA-1A Aircraft, AA1B-0001 Thru AA1B-AA5-0001 Thru AA5-

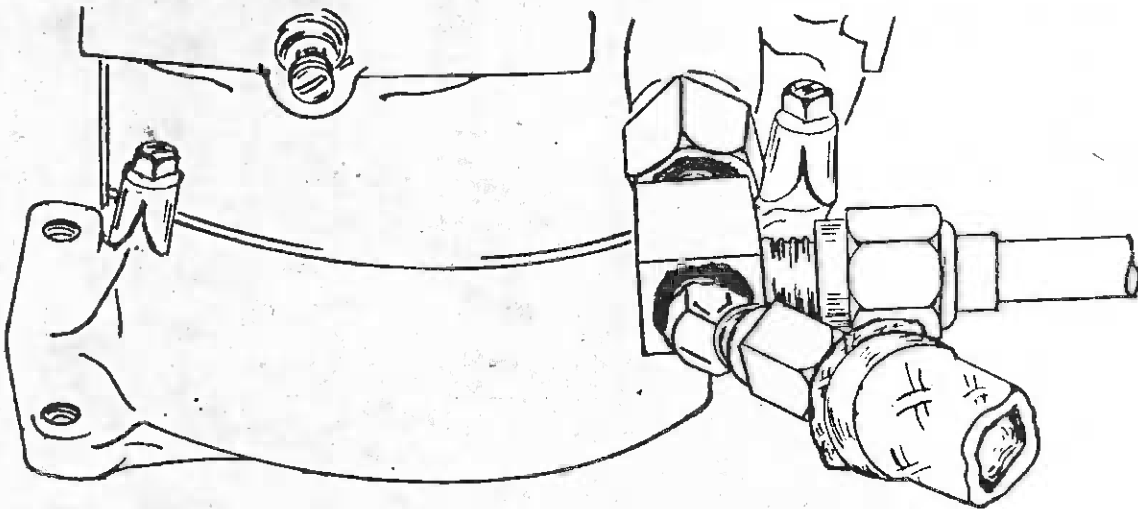
Several reports have been received of fuel seepage in the engine compartment at the joint between the fuel pressure gauge line fitting and the carburetor fuel inlet tee fitting. (See Figure 1). This condition, if allowed to continue, could result in hazardous operation due to fuel vapors in the engine compartment. AA1B-0 and on and AA5-0 and on are not affected by this Bulletin, as a fitting with a brazed joint has been incorporated on these aircraft.

It is recommended that at each scheduled inspection the fuel system be pressurized using the auxiliary fuel pump and this joint in particular be inspected for fuel seepage.

Any seepage that exists should be corrected as necessary using "Tite Seal" or equivalent on all pipe threads. Use "Tite Seal" sparingly and omit from first two (2) threads of male fittings.
