DATE: February 20, 1973
SUBJECT: Carburetor Air Box Modification
SERIALS AFFECTED: AA5-0001 through AA5-0300
TIME OF COMPLIANCE: Within the next 100 hours of operation or at the next scheduled inspection, whichever occurs first.

GRUMMAN AMERICAN AVIATION CORPORATION

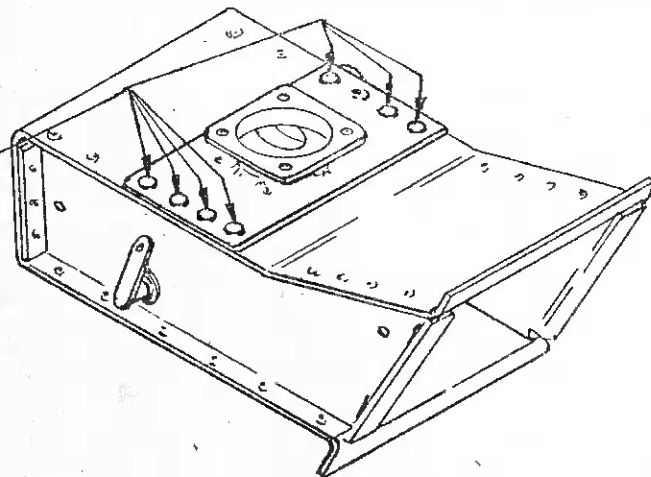
FIGURE 1. CARBURETOR AIRBOX RIVET REPLACEMENT

Field reports have been received which indicate that the steel stem aluminum pop type rivets which are used to attach the steel adapter flange assembly to the carburetor air box are working loose in service. In order to reinforce this attachment area, production aircraft AA5-0301 and on will be produced with solid rivets at this attachment point.

Remove the existing seven (7) pop rivets as shown on Figure 1 and replace with seven (7) rivets, part no. MS20470AD-4. It is not necessary to remove the air box assembly from the carburetor to incorporate this modification. Visually inspect the entire air box.

Remove (7) existing Pop Rivets. Replace with (7) MS20470AD-4 Solid Rivets.
