SERVICE BULLETIN NO. 136

DATE: February 20, 1973
SUBJECT: Elevator Trim Tab Hinge Inspection
SERIALS AFFECTED: AA5-0001 through AA5-0284
TIME OF COMPLIANCE: Within the next 100 hours of operation

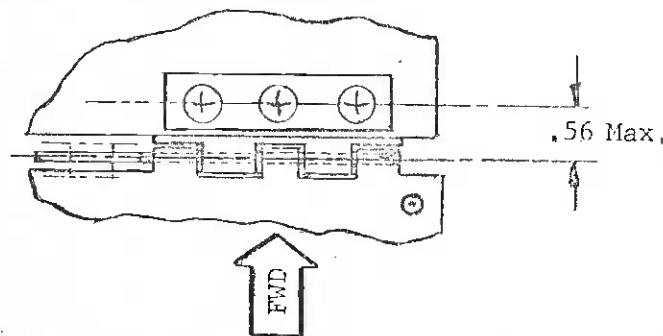
FIGURE 1. ELEVATOR TRIM TAB HINGE INSPECTION

Some aircraft in the above serial number range may have been produced with insufficient hole edge margin in the elevator trim tab outboard forward hinge halves. To prevent possible detachment of the hinge half, the following inspection and modification, if required, must be accomplished within 100 hours of operation.

Measure the distance from the center of the trim tab hinge pin to the center of the three (3) mounting screws in the elevator tip on each elevator. The maximum allowable dimension is .56" (see Figure 1). If the dimension is larger than .56", the forward hinge half must be modified or replaced. If the dimension is less than .56", no further action is required and the aircraft can continue in service.

Remove the three (3) hinge half mounting screws in the elevator tip, the cotter pin retaining the hinge pin and remove the hinge pin. Remove the hinge half from the tip. Reinstall hinge pin to support trim tab. Fabricate a doubler of 2024-T3 clad aluminum, .040" thick x 1.00" x 2.50". Assemble the doubler to the hinge half as shown in Figure 2. Match drill mounting holes through tip and doubler. Assemble in reverse order and compensate for the added doubler thickness by eliminating shims as required during reassembly in tip.

- a. Alternate repair method no. 1 is to order a replacement hinge half, part no. 5901034-4 (one for each elevator tip - if required). This hinge half has a longer flange, can be drilled to match the existing tip holes and will directly replace the old hinge half.
- b. Alternate repair method no. 2 is to fabricate a new hinge half (one for each elevator tip - if required), to match the existing hinge half from locally procured MS20257-5 hinge stock material.
