SERVICE BULLETIN NO. 137A
Supersedes SB No. 137

DATE: June 22, 1973
SUBJECT: Engine Mount Inspection
SERIALS AFFECTED: AA5-0175 through AA5-0290
TIME OF COMPLIANCE: Within 25 hours of operation

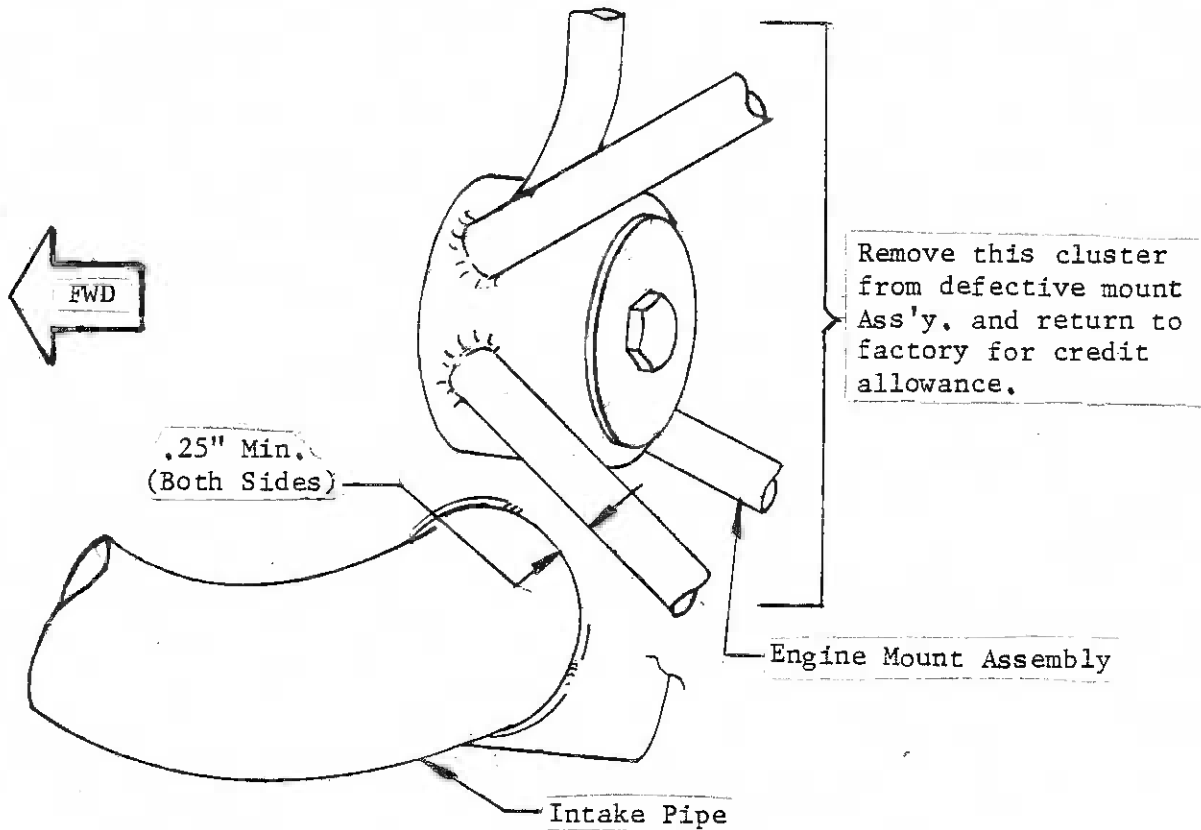
FIGURE 1. ENGINE MOUNT/INTAKE PIPE CLEARANCE INSPECTION
(LH shown, RH opposite)

Some aircraft within the above serial number range may have been produced with engine mounts that provide insufficient clearance between the engine mount and the air intake pipes on number 3 and number 4 cylinder.

Inspect clearance between engine mount and #3 and #4 air intake pipes as shown on Figure 1. NOTE: CLEARANCE IS TO BE .25" MINIMUM.

If clearance is .25" or greater, no further action is required and the aircraft may be returned to service.

If clearance is less than .25", but no evidence of physical contact between the engine mount and the air intake pipes exists, the aircraft may be returned to service, but the engine mount must be replaced within 100 hours of operation or at the next scheduled inspection, whichever occurs first.

If clearance is less than .25" and evidence of physical contact between the engine mount and air intake pipe exists, the engine mount must be replaced within 10 hours of operation and the intake pipe checked for cracks before further flight. Replace intake pipe before further flight if required.
