SERVICE BULLETIN NO. 144A
SUPERSEDES SB NO. 144
"FAA DCA EA-4 APPROVED"

DATE: March 12, 1975
SUBJECT: MIXTURE CONTROL
SERIALS AFFECTED: All Model AA-1, AA-1A and AA-1B.
TIME OF COMPLIANCE: Within the next 50 hours of operation; thereafter,
as indicated in text.

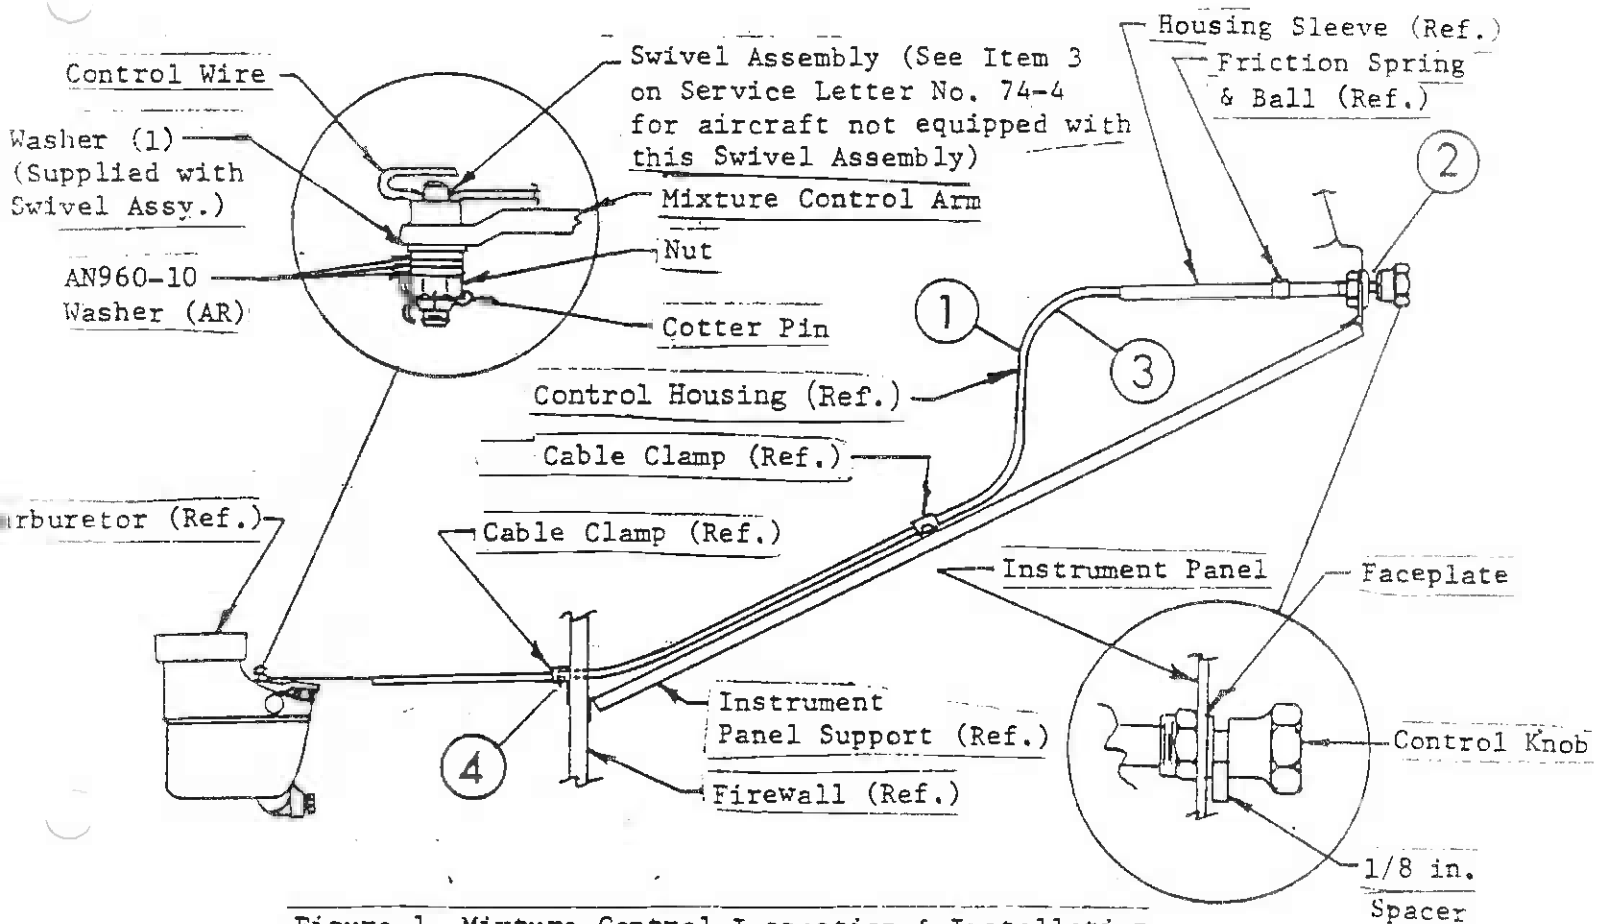
Figure 1. Mixture Control Inspection & Installation

Field reports indicate that some mixture control wires on the aircraft affected, may be subject to failure due to wear, kinks, or improper rigging. An investigation of the failed wires indicates that a detailed inspection and strict adherence to the rigging information contained in the service manual, are required at each scheduled inspection.

1. Cycle the control knob between the full rich and idle cutoff position, and observe the control housing for a "snaking" movement. Movement of the housing indicates that the control wire is kinked and must be replaced.
2. Place the control knob in the idle cutoff position, grasp the mixture control arm and move arm to the full rich position. Measure the additional travel (sponge) remaining between the faceplate and control knob. Replace mixture control wire, if the additional travel remaining exceeds 1/8 inch.

3. The control housing minimum bend radius is $4\frac{1}{2}$ inches throughout its entire routing. If necessary, adjust housing and replace mixture control wire, if the minimum bend radius is less than $4\frac{1}{2}$ inches.
4. The firewall cable clamp must direct the control housing at right angles to the firewall. If necessary, adjust to achieve this condition.
5. Perform a final check of the mixture control for proper travel, security, operating condition and control cushion (sponge).

In addition to the inspection and rigging requirements, all mixture control wires are to be removed from service after they have accumulated a total time in service of 500 hours. Mixture control wires with more than 500 hours time in service, must be replaced within 50 hours; thereafter, at 500 hour intervals.

If service life limit or inspection of the control wire dictates replacement, a Control Wire/Knob Assembly is available under part number 507001-3 at \$4.50 (E) each. Refer to Figure 1 for proper installation.

1. Remove friction spring and ball from housing sleeve, detach control wire from mixture control arm at swivel assembly and remove control wire from aircraft.
2. Route replacement control wire/knob assembly through existing control housing and loosely attach to the swivel assembly.
3. Position the mixture control arm completely against the full rich stop and place a 1/8 inch spacer between control knob and faceplate.
4. With the mixture control arm against the full rich stop and the control knob against the spacer, tighten swivel assembly. Remove spacer from control knob and check mixture control for proper travel, security, operating condition and control cushion (sponge).
5. Bend mixture control wire as shown and install cotter pin. Check swivel freedom in arm.
6. Attach friction spring and ball to housing sleeve.
