SUBJECT: FUEL LINE INSPECTION

SERIALS AFFECTED: AA5A-0001 through AA5A-0124 having optional long-range fuel tanks
AA5B-0001 through AA5B-0258

Immediately on completion of work, a Service Reply Card (attached), is to be completed and returned, noting compliance with the requirements of this Service Bulletin No. 154.

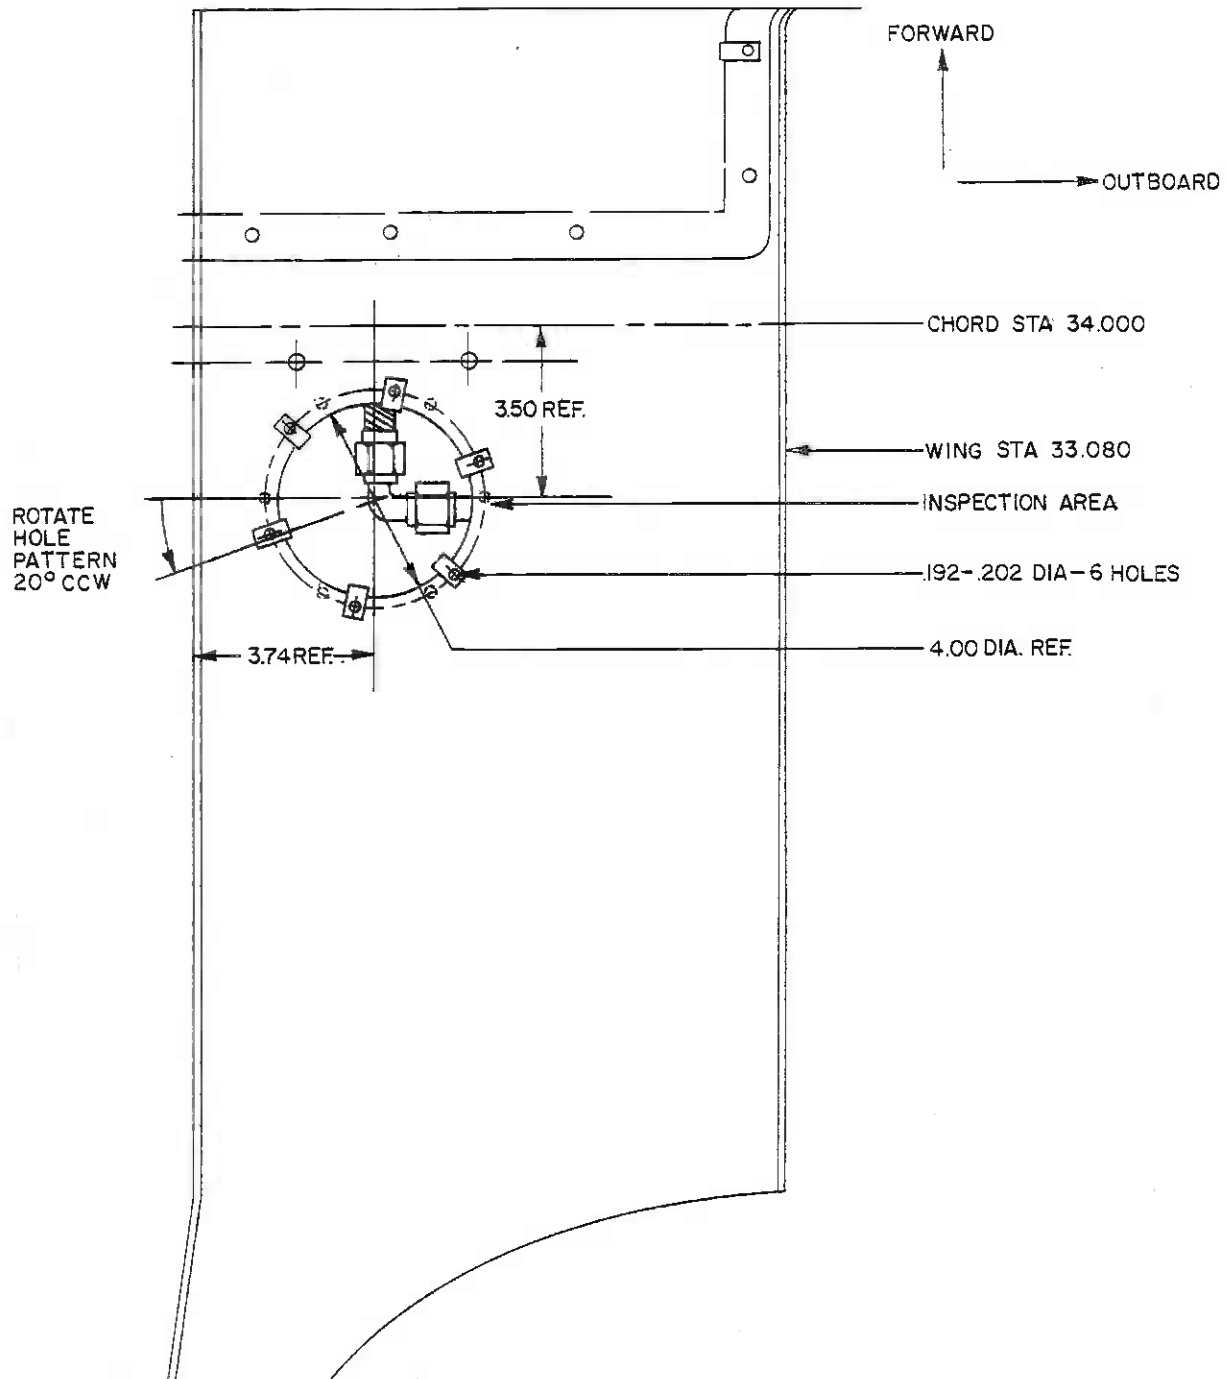
Figure 1. Wing Root Installation (Left-Hand Shown, Right Hand Similar)

A few reports have been received of interference between the aft spanwise fuel line and the wing root access cover outboard attach screw.

1. Prepare the airplane for safe maintenance. Remove the aft inspection cover from the underside of the left and right wing roots. The inspection covers are each secured with six screws.
2. In the area of the inspection cover outboard attach screw, inspect the wing fuel lines for chafing.
3. If chafing is evident, measure the fuel line wall thickness reduction at its deepest point.
4. If chafing results in a fuel line wall thickness reduction of more than 0.006 inch, replace the fuel line. If the reduction is 0.006 inch or less, the line may be polished to remove stress concentrations and returned to service.
5. If chafing was noted above, or if the most outboard attach screw is vertically aligned with the fuel line, modify the inspection cover installation as indicated below.

NOTE: To avoid possible interference with the fuel line beyond the elbow, locate the new holes exactly as indicated below.

1. In the left wing root, use the inspection cover as a template to locate six holes rotated 20 degrees counterclockwise from the existing holes.
2. Drill six 0.192/0.202 inch holes at the new locations.
3. Move the clip nuts to the new holes. Temporarily install the screws closest to the fuel line. Deflect the fuel line downward by hand to make sure no interference exists between the fuel line and the screws.

4. Remove the screws, install the inspection covers, and secure with screws.
5. In the right wing root, use the inspection cover as a template to locate six holes rotated 20 degrees clockwise from the existing holes.
6. Repeat Steps 2. through 4. above.
