Gulfstream American

SERVICE BULLETIN NO. 163
"FAA (DER) APPROVED"

SUBJECT: AILERON TORQUE TUBE INSPECTION AND MODIFICATION

SERIALS AFFECTED: AA5A-0176 thru AA5A-0805, AA5B-0302 thru AA5B-1078 and all Spares stock of Part No. 5202035-505 shipped from the factory between May, 1976 and January, 1979.

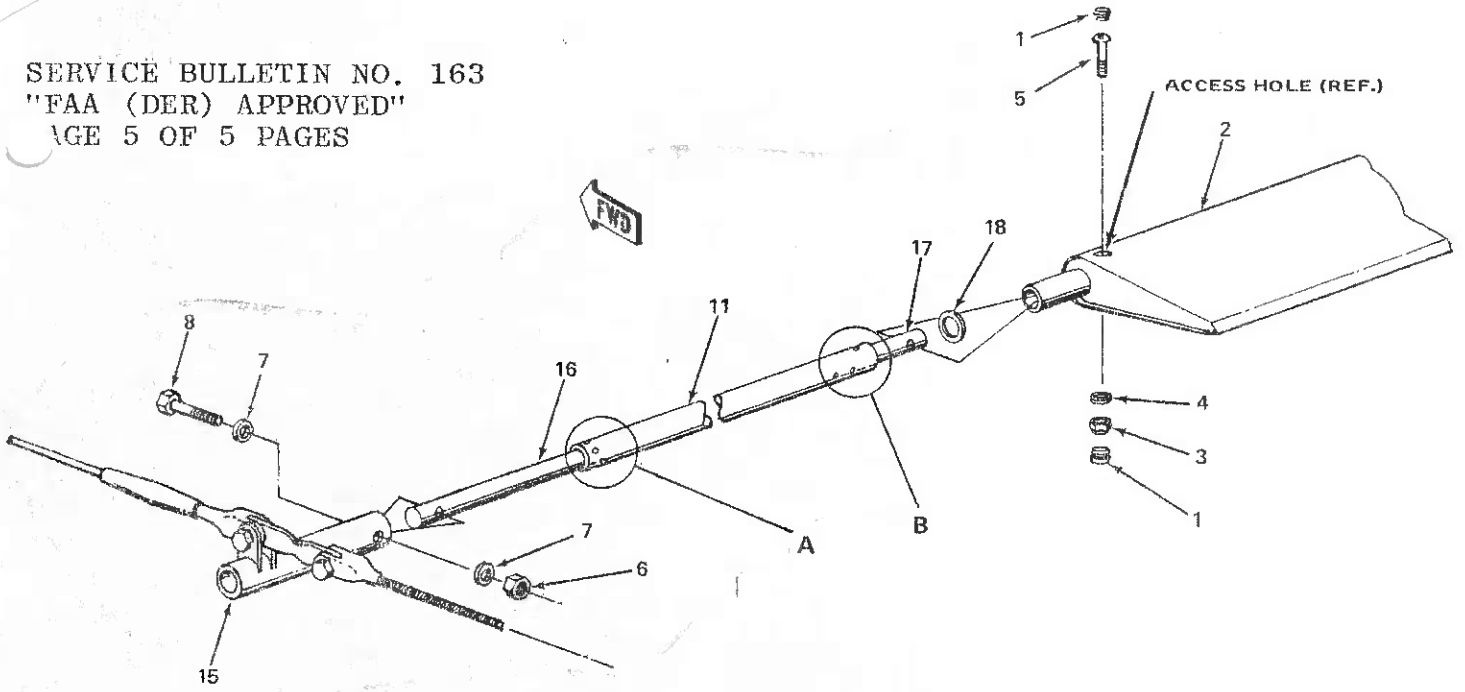
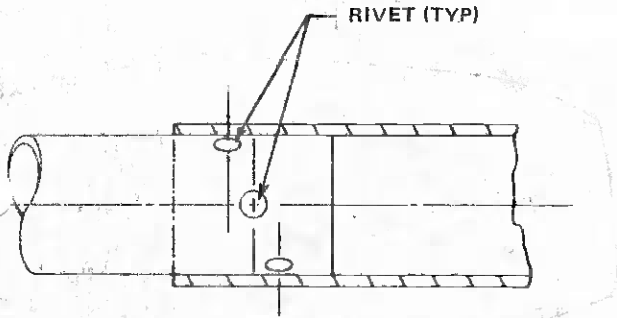
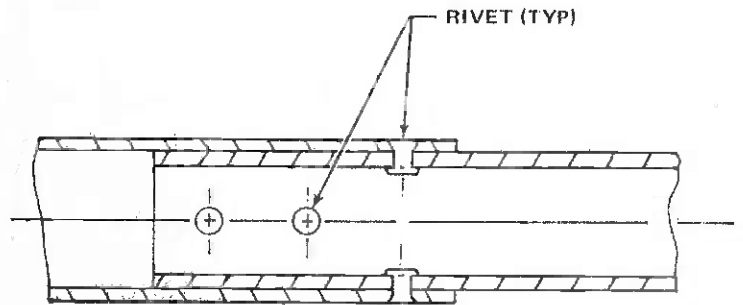
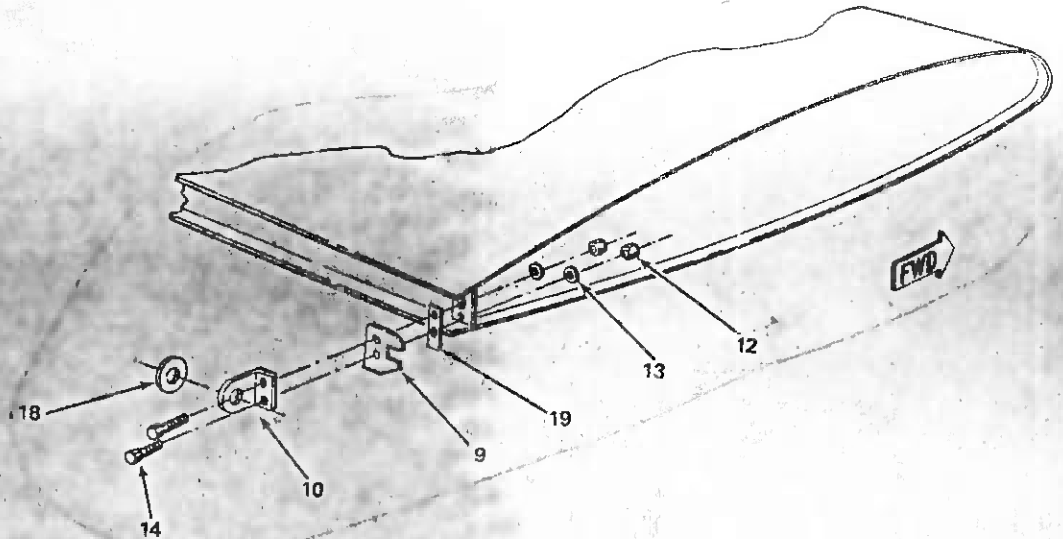
FIGURE 1

The aileron torque tube assembly, Part No. 5202035-505, contains two joints that require inspection (REFER TO FIGURE 1). The torque tube assembly extends inboard from the aileron and may be separated from the aileron by removing attach hardware through access holes in the aileron skin at the inboard end. Ailerons on affected aircraft requiring inspection may be identified by visually inspecting for these access holes. On aircraft on which ailerons do not have these access holes, the aileron torque tube is an integral part of the aileron and thus is not affected by this Service Bulletin.

Referring to Figure 1, the aileron torque tube assembly requiring inspection consists of a tube, Part No. 5202035-11 (11), an inboard sleeve, Part No. 5202035-6 (16), and an outboard sleeve, Part No. 5202035-11 (17). These sleeves (16 and 17) are to be assembled to the tube (11) with bonding agent or rivets and bonding agent. This Service Bulletin is intended to provide the necessary instructions for inspection of the assembly joints to verify that assembly was completed with bonding agent or rivets and bonding agent. If, however, assembly was with rivets only, modification must be accomplished in accordance with the instructions provided in Service Kit SK-144.

- (1) Visually inspect both inboard and outboard torque tube joints for assembly with bonding agent or rivets and bonding agent. When inspecting to see if a joint is bonded, it may be possible to see bonding agent around the circumference of the joint, where the tube and sleeve mate. If joint is not bonded, proceed with modification in accordance with Service Kit SK-144.
- (2) If unable to visually determine if joint was assembled with rivets and bonding agent, rivets must be removed as per instructions in Service Kit SK-144.

- (a) If unable to separate, reinstall rivets (Part No. CR3242-5-4 supplied in Service Kit SK-144) as per instructions in Service Kit SK-144.
- (b) If able to separate, joint must be modified in accordance with instruction in Service Kit SK-144.
