American General Aircraft Corporation

CRITICAL SERVICE BULLETIN

SB-184

DATE: JULY 10, 1993
SUBJECT: AILERON CONTROL INTERFERENCE
MODEL / SERIALS AFFECTED: AG-5B 99998 and 10000 through 10158
TIME OF COMPLIANCE: Prior to the next flight

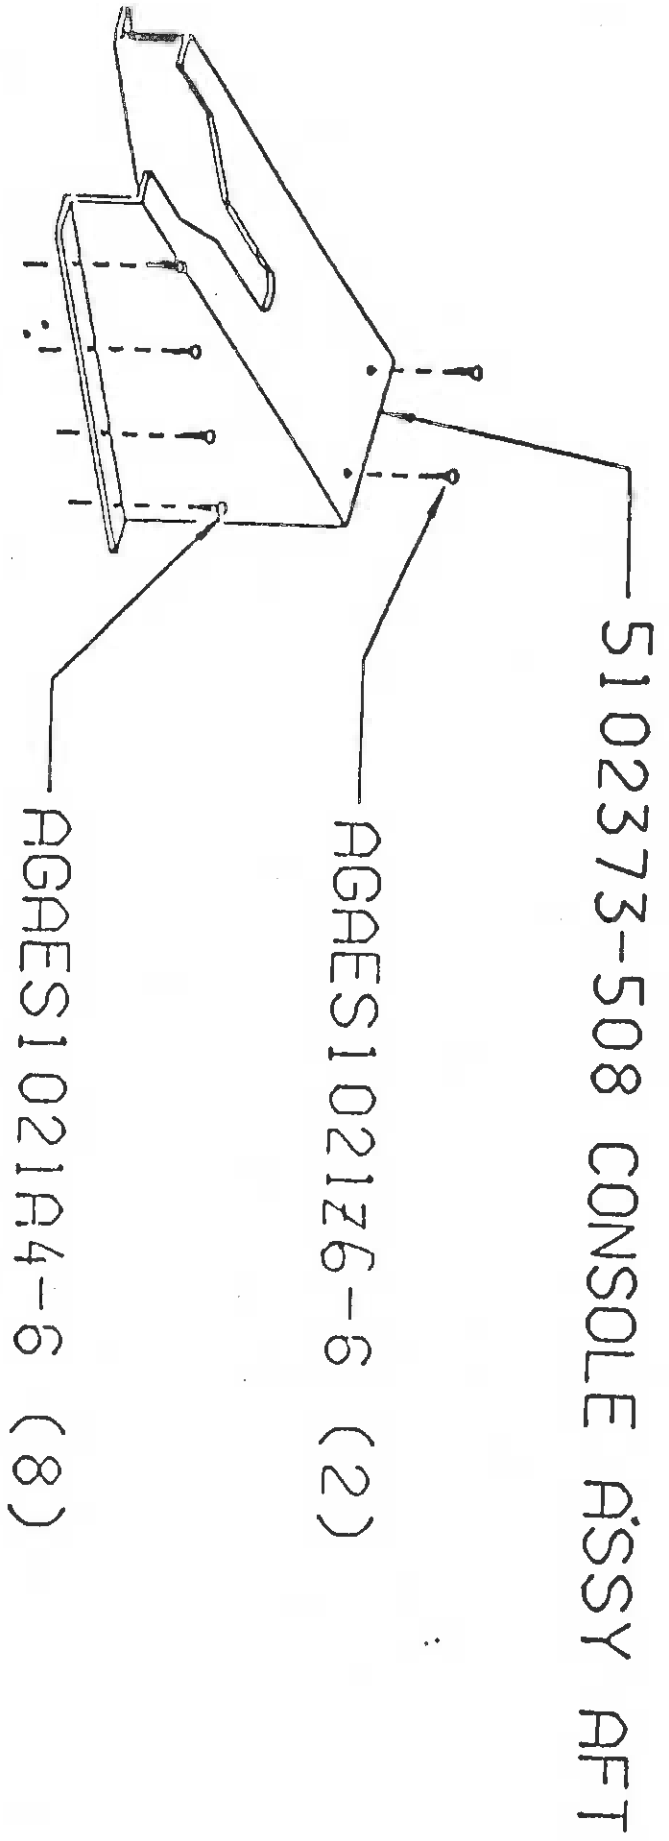
FIGURE 1

We have received reports of the aft center console assembly P/N 5102373-508 on some of the above mentioned aircraft collapsing as a result of being stepped on by a rear seat passenger and interfering with aileron control cables and turnbuckles located under the console. This interference can result in partial loss of aileron control which would compromise the continued safe operation of the aircraft.

It is suspected that some of these aircraft were manufactured without the two screws installed that attach the center console to the rear seat forward bulkhead. These screws secure the aft end of the center console to an angle bracket, that is attached to the rear seat forward bulkhead, which prevents the console cover from being forced under the bracket when pressure is applied to the top of the console.

1. Peel back the rear edge of the aft center console carpet so that a minimum of one inch of the top of the metal console can be seen.
2. Check for the installation of two (2) AGAES1021Z6-6 screws which secure the 5102373-508 console to the rear seat forward bulkhead. (FIGURE 1)

1. Remove the eight (8) AGAES1021A4-6 retaining screws (FIGURE 1) and remove the aft center console.

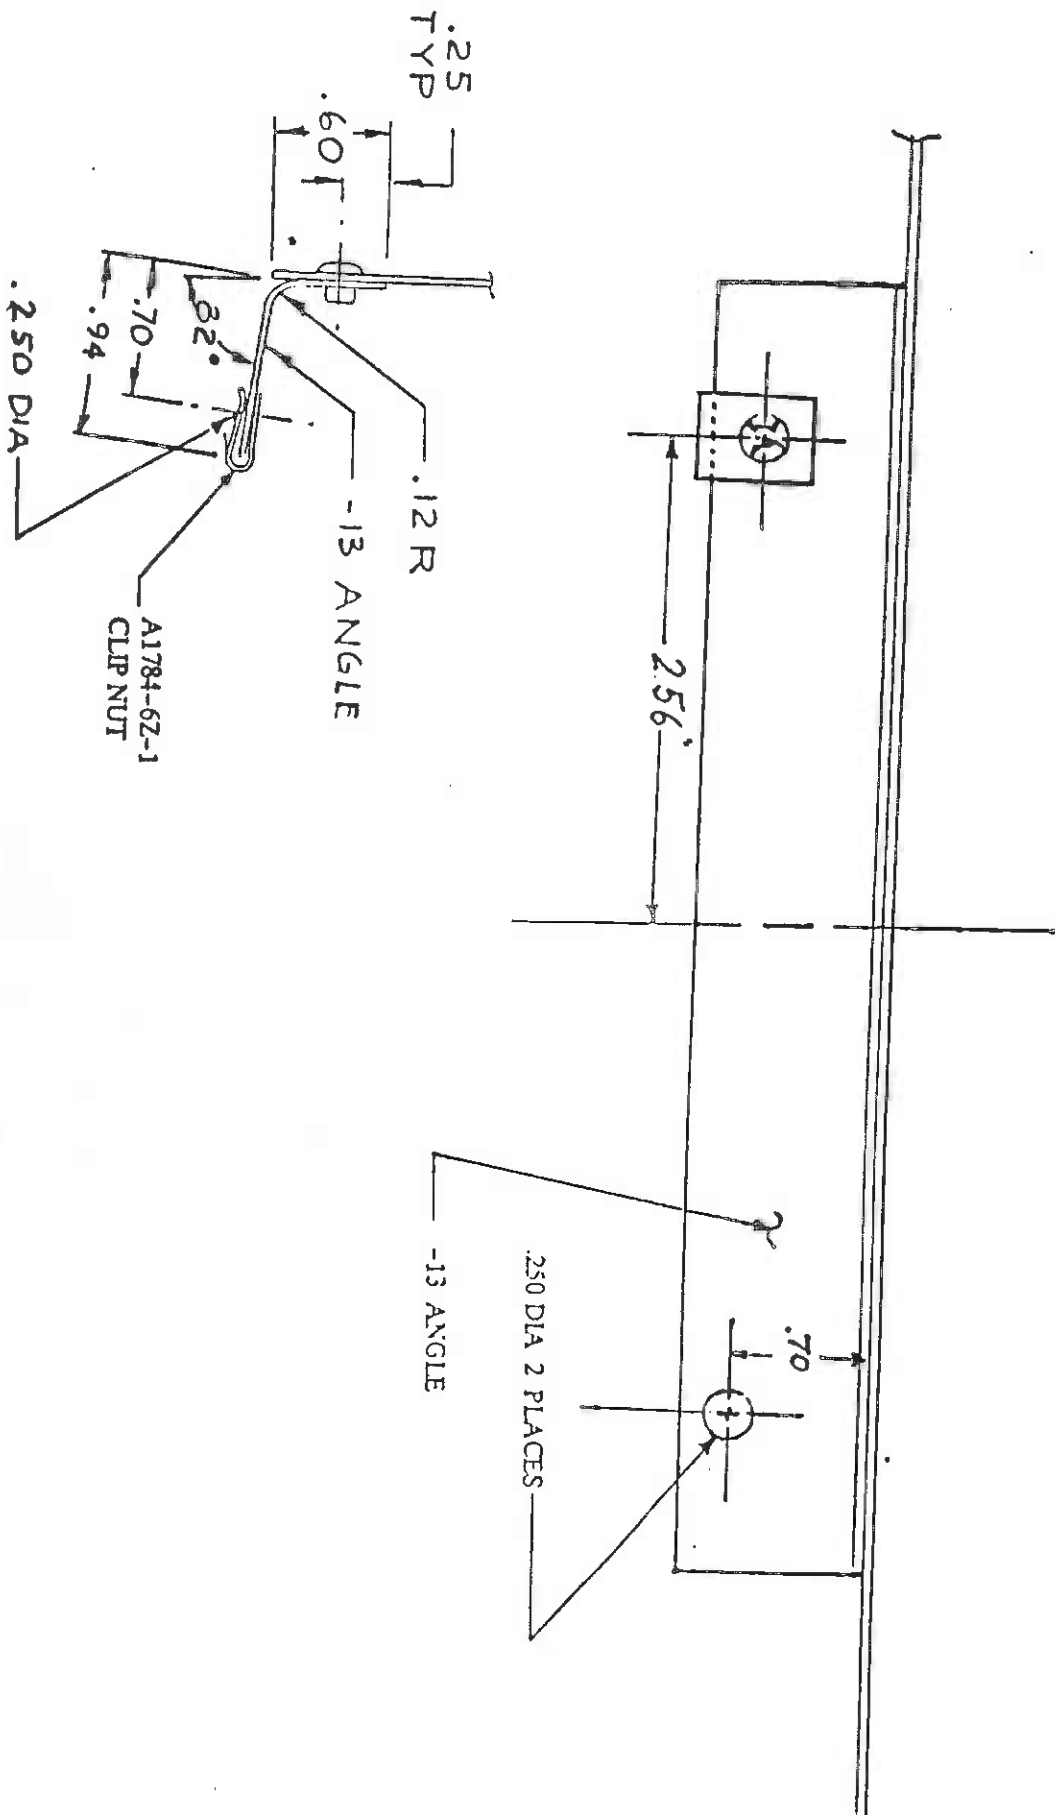
There may be holes with clip nuts installed on the -13 angle. If the holes are located per the drawing in FIGURE 2, proceed with step (4). If the holes are not in the proper location, remove the clip nuts and proceed with step (3).

2. Locate the -13 angle on the forward rear seat bulkhead. (FIGURE 2)

3. Locate and drill (2) 0.250 inch diameter holes in the -13 angle per the FIGURE 2 drawing and install (2) A1784-6Z-1 clip nuts.
4. Position the -508 console assembly in place and using a #26 drill bit, match drill (2) 0.147 inch diameter holes in the console to align with the holes in the -13 angle.
5. Secure the -508 console to the -13 angle using (2) AGAES1021Z6-6 screws and to the floor using the previously removed (8) AGAES1021A4-6 screws.
6. Re-secure any carpet removed for access.
7. Record compliance in the aircraft log book and return the aircraft to service.
8. Complete the attached compliance card and mail to:
