American General Aircraft Corporation

CRITICAL SERVICE BULLETIN

SB-185

SUBJECT: **WING ATTACH SHOULDER BOLTS**

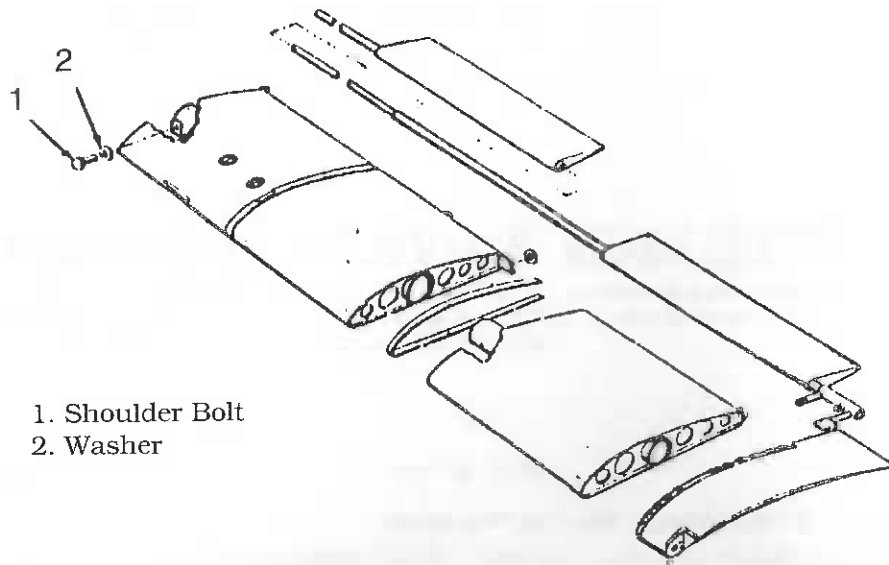
FIGURE 2

We have received reports of inboard wing attach shoulder bolt (P/N 901044-2 and -3) failures on some of the above mentioned aircraft which may compromise the structural integrity of the aircraft and could result in loss of flight control should the second bolt in either wing fail. These failures were detected during routine scheduled 100 hour inspection while retorquing the wing attach shoulder bolts and had failed prior to reaching the bolt service life limit of 7,250 hours. No abnormal flight characteristics have been experienced prior to discovery of the broken shoulder bolts.

It is suspected that wing attach shoulder bolt failures occurred because of excessive wing to center spar clearance caused by the failure to check and to shim to the correct tolerance, per the Gulfstream Aerospace Corporation AA-5 Series Maintenance Manual Chapter 57, during wing installation after a major repair.

1. Prepare the aircraft for safe maintenance.
 - a. Disconnect the battery.
 - b. Connect the airframe to a suitable ground.
2. Remove the access panel from the lower wing root fairing (Figure 1).
3. From within the wing root, remove the (2) wing attach shoulder bolts (Figure 2) at each wing root main spar.
4. Inspect each of the four P/N 901044-3 wing attach shoulder bolts as follows:

- a. Through the access panel under the wing root fairing, install the shoulder bolt and washer and tighten until the head of the bolt contacts the spar.
- b. Rotate the bolt counter clockwise two full turns then using a torque wrench, determine the friction drag on the bolt.
- c. Add the friction drag to 85 inch pounds to establish the total torque value and torque the shoulder bolt.
- d. Repeat steps (a), (b), and (c) for each of the remaining shoulder bolts.

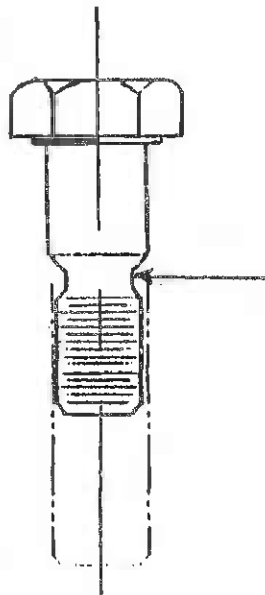
FIGURE 3

- a. Inspect for fretting or scoring to the shoulder of the bolt. If there is any wear resulting in removal of the cad plating from the shoulder of the bolt, the bolt must be removed from service and a new bolt installed.
- b. Inspect the Shoulder Bolt profile. The Shoulder Bolt should have a machined smooth between the threads and the shoulder bevel as shown in Figure 3. If the threads contact the shoulder of the bolt, the bolt must be removed from service and replaced with a bolt of the correct profile.
