SERVICE KIT NO. SK-111

DATE: July 19, 1971  
 TITLE: Rudder/Elevator Tip Rib Modification  
 SERIAL AFFECTED: AA1-0001 thru AA1-0458, AA1A-0001 thru AA1A-0239  
 WEIGHT AND BALANCE CHANGE: Negligible

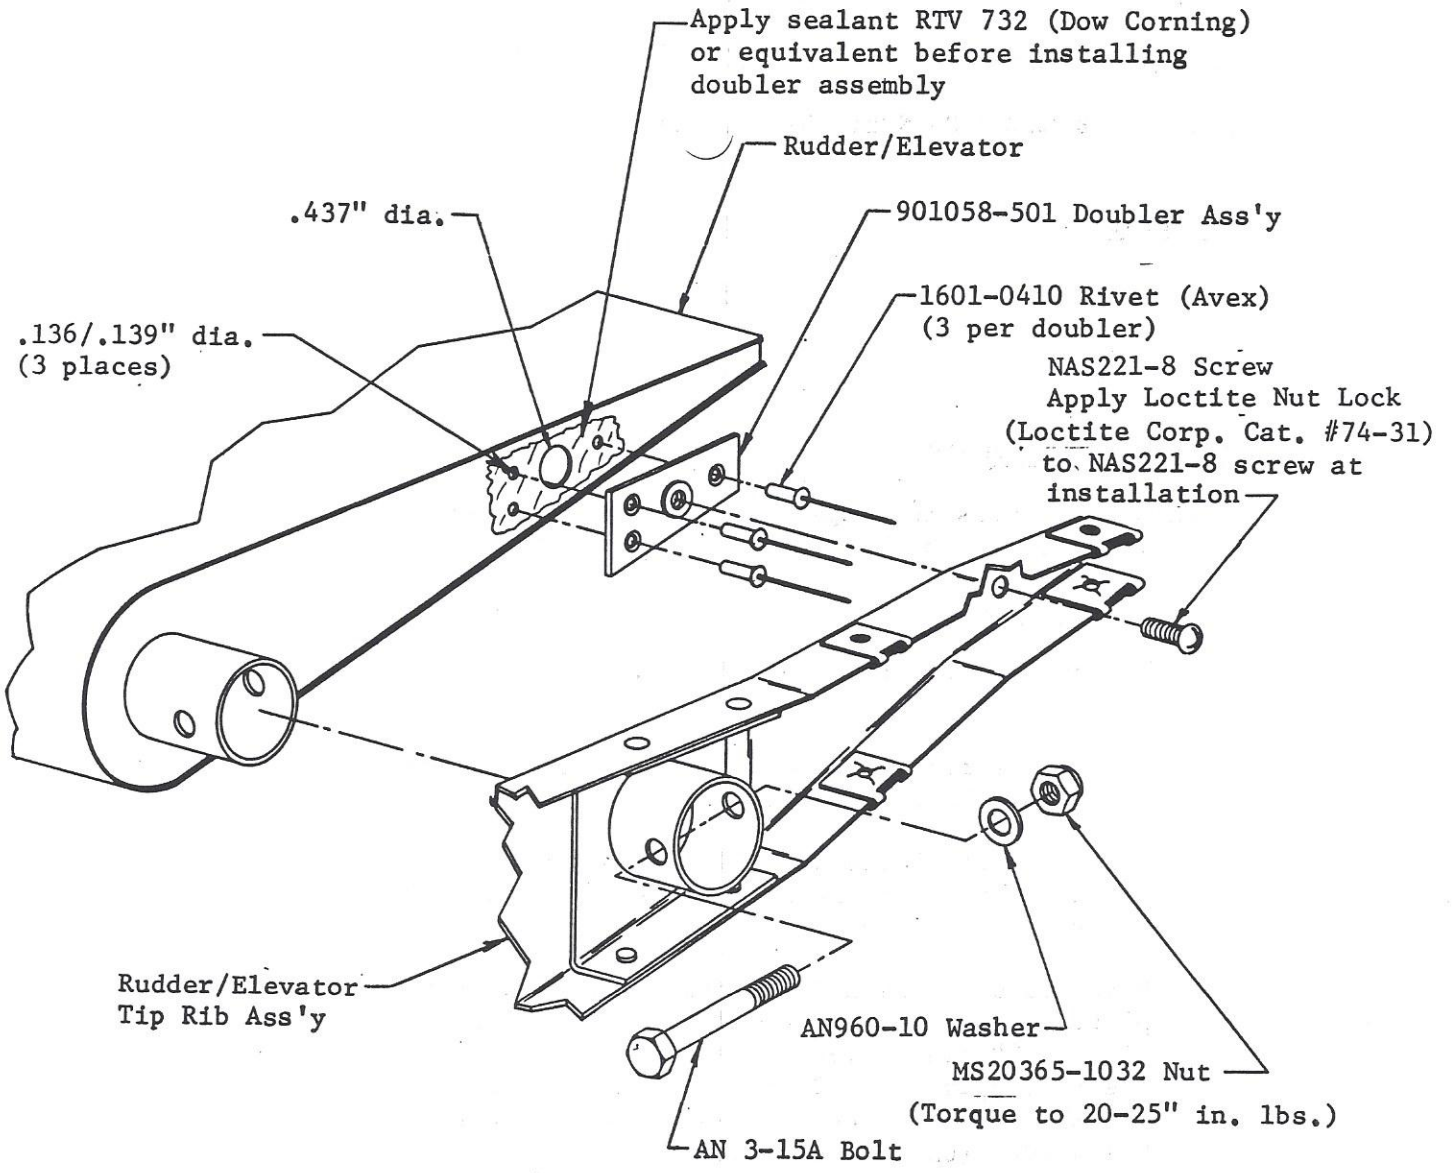
Figure 1. Rudder/Elevator Tip Rib Modification

This kit covers the repair of a loose or pulled rivnut in the outboard rib of the vertical and/or horizontal control surfaces.

1. Remove the 12 screws securing the control surface tip and remove the tip.
2. Remove the rib attach bolt, washer and nut, then remove the NAS221-8 screw and the tip rib assembly.
3. Drill out the loose or pulled rivnut with a .250"dia. drill. After rivnut is removed, redrill existing rivnut hole to .437"dia. thru outer face sheet only.
4. Place doubler assembly on control surface rib and use it as a template to mark the three (3) rivet hole locations. Drill three (3) .136/.139" dia. rivet holes through the outer face sheet skin of the rib, apply RTV 732 (Dow Corning) Sealant and attach doubler assembly using three (1601-0410) rivets per doubler using "pop" rivet tool (United Shoe Machinery Co. P/N PRG410 or equivalent).
5. Install tip rib assembly and tip (Torque rib attach bolt and nut assembly to 20-25 in. lbs).

Apply Loctite Nut Lock (Loctite Corp. Cat. #74-31) to NAS221-8 screw at installation.
