SERVICE KIT NO. SK-117

DATE: August 7, 1972
~~TITLE:~~
~~SUBJECT:~~ Flap Position Indicator Modification
 SERIALS AFFECTED: AA5-0001 thru AA5-0140
 WEIGHT AND BALANCE CHANGE: Negligible

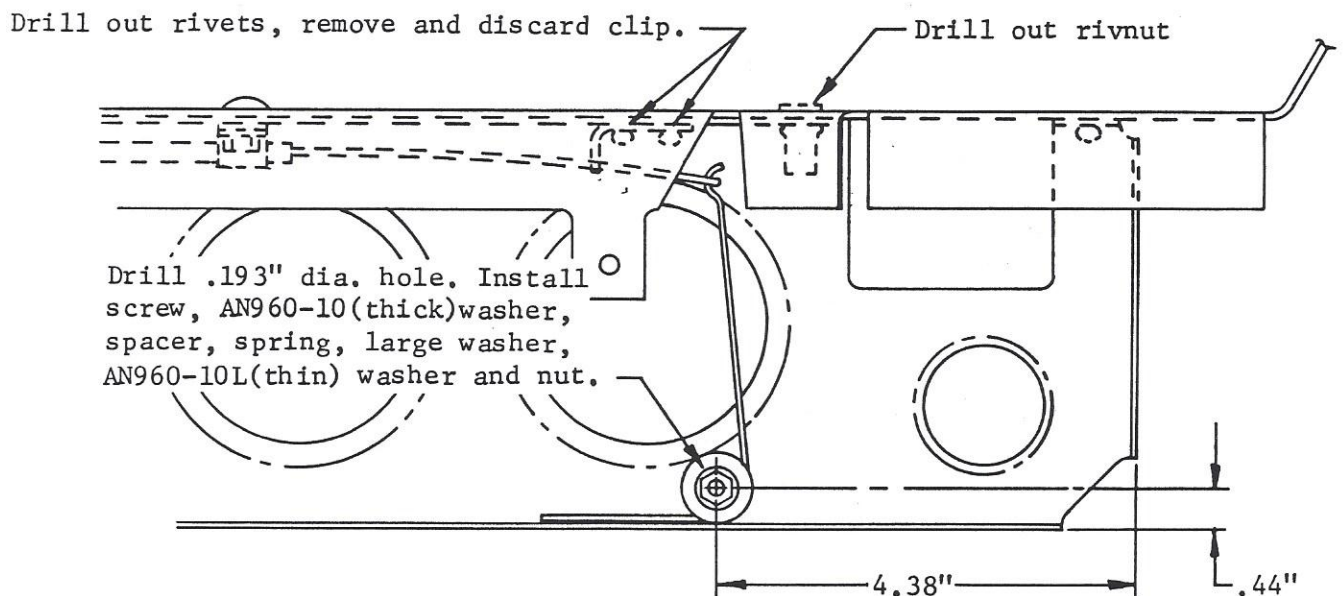
Figure 1. Flap Position Indicator Modification.

On production aircraft, AA5-0141 and up, the flap position indicator cable assembly has been redesigned to incorporate a return spring at the forward end of the indicator wire, inside the console. The addition of this spring provides a smoother, more positive flap position indicator movement. Aircraft below AA5-0141, which experience erratic flap position indicator operation, can be modified as follows:

6. Drill a .193 diameter hole through the console support to mount the spring. Locate as shown in Figure 1.
7. Install the spring retaining hardware in the following sequence: AN526-1032R-14 screw, AN960-10 washer, AES 201-6 spacer, 5604004-1 spring, A3235-028-24A washer, AN960-10L washer and the MS20364-1032 nut.

8. With the flaps fully retracted(0° position) pull indicator wire forward as far as possible and bend a small loop(approximately 1/8" radius) in the end of the indicator wire 1/2" aft of the ash tray cut out. Connect the return spring to the indicator wire and check for positive clearance with the ash-tray.

9. Cycle the flaps, observing the alignment of the indicator wire in the slot. Bend the spring arm slightly to properly center the wire in the slot, if required.
