# SINGLE ENGINE AIRCRAFT SERVICE KIT NO. 144

**SUBJECT:** FLIGHT CONTROL (ATA NO. 27) AILERON TORQUE TUBE, MODIFICATION OF

JUNE 4, 1979

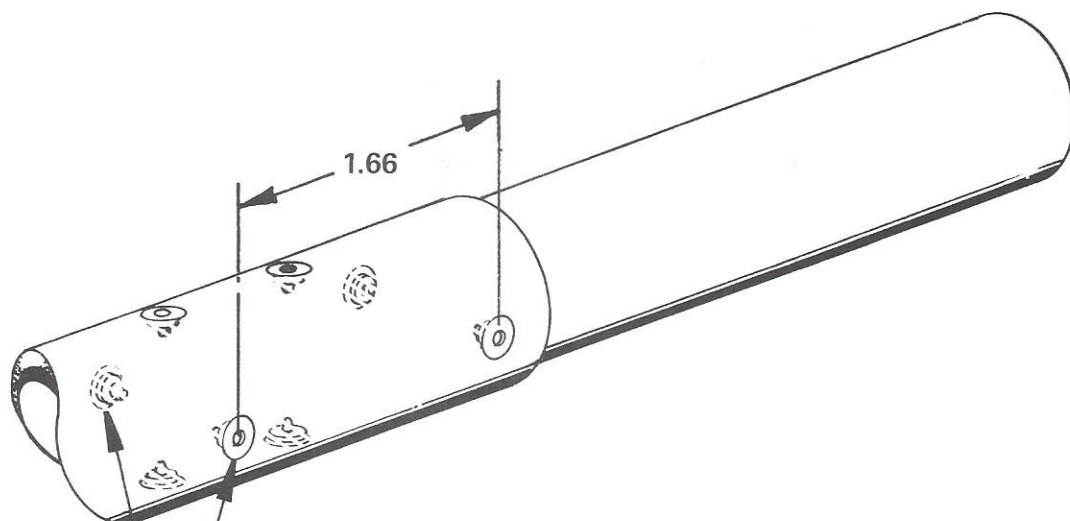
FIGURE I

ADD HOLES  
 (TYPICAL 2 PLACES)  
 DRILL .176 - .180  
 COUNTERSINK 100° X  
 .290 DIA., 8 HOLES  
 OUTBOARD JOINT

- B-4 Clean torque tube mating surface by lightly sanding with 360-400 grit Carborundum (non-silicone) paper.
- B-5 Reassemble joint and drill existing holes to .176 - .180 and countersink 100° x .290 DIA. Also drill two new holes at each end of the torque tube (.176 - .180) as shown in Figure 1, countersink holes 100° x .290 DIA.
- B-6 Separate tubes and remove all chips and lightly debur all holes.
- B-7 Using MEK or Acetone and a clean rag clean the mating surfaces.
- B-8 Mix epoxy per package instructions (Loctite 'Clear' Epoxy Kit # 446).

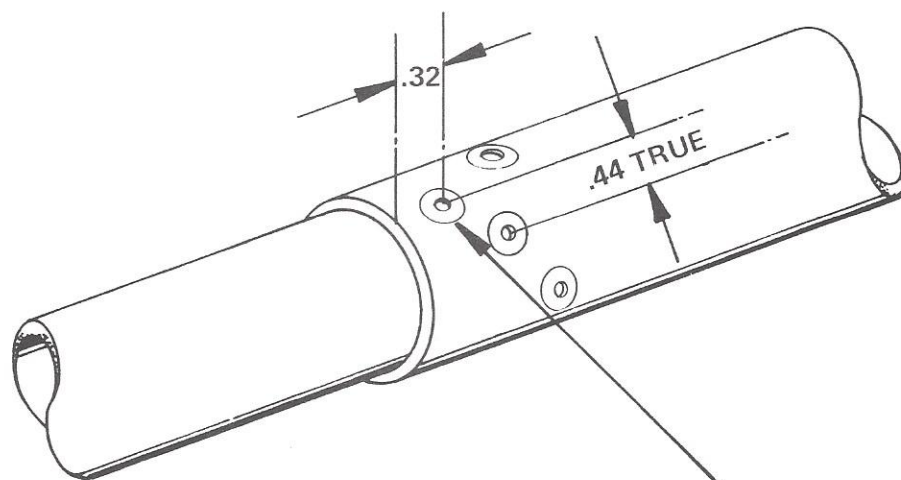
ADD HOLES  
 (TYPICAL 2 PLACES)  
 DRILL .176 - .180  
 COUNTERSINK  
 100° X .290 DIA.,  
 INBOARD JOINT
