**SERVICE LETTER NO. 71-11A**  
**Supersedes Service Letter No. 71-11**

**SUBJECT:** Bungee Inspection

**SERIALS AFFECTED:** All Model AA-1 and AA-1A aircraft.

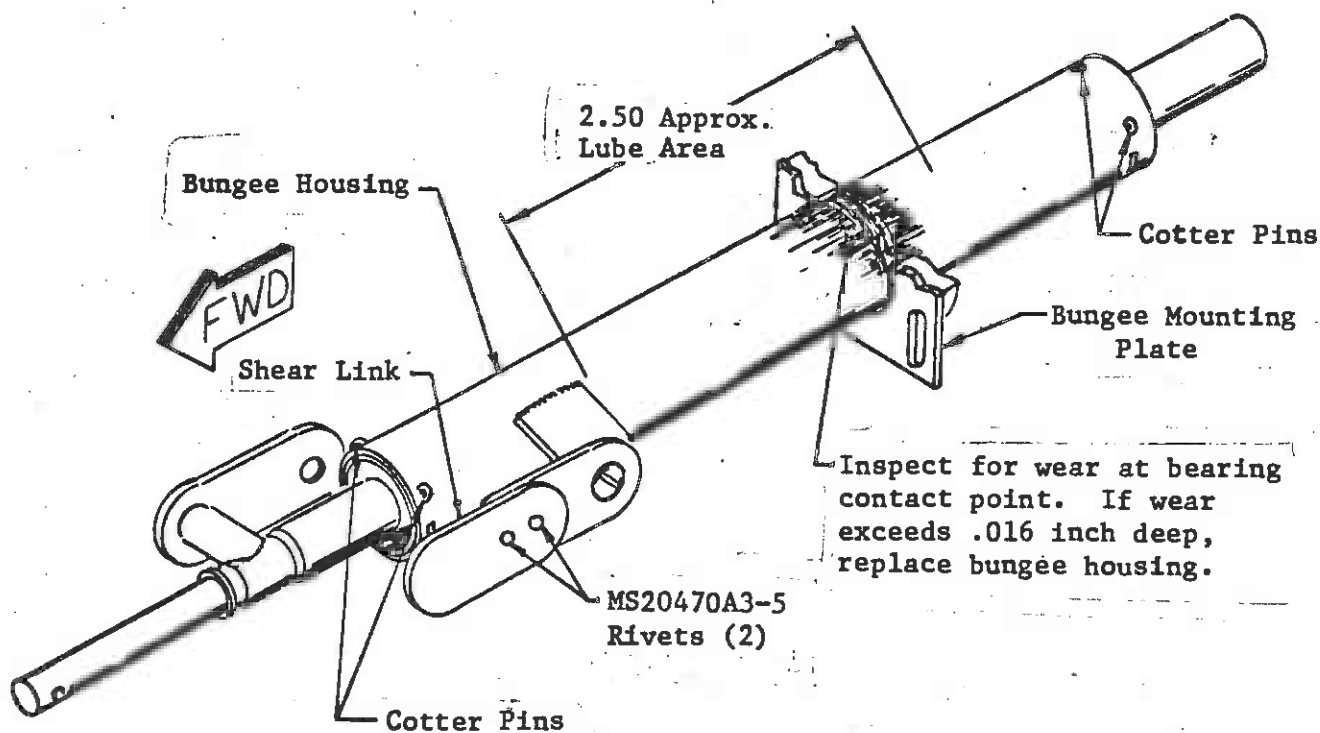
Figure 1. Bungee Assembly

Field reports indicate that on aircraft with 500 or more hours, the bungee housing outer surface may show excessive wear at the support bearing, or the rivets, which secure the shear link, may have become loose (See Figure 1).

1. Inspection of the bungee housing outer surface. If wear is more than .016 inch deep, the bungee housing assembly (part no. 607004-701) \$19.72 (H), should be replaced.

2. Inspect two (2) MS20470A3-5 rivets in shear link. If loose rivets are found, they should be replaced with identical soft rivets, or the shear link (part no. 607004-503) \$2.08 (H), should be replaced.
