SERVICE LETTER NO. 71-13

DATE: December 10, 1971

SUBJECTS: Item 1. Stall Warning Wire Relocation  
Item 2. Master Cylinder Operation  
Item 3. Windshield/Canopy Improvement  
Item 4. Nose Gear Fork Installation  
Item 5. Canopy Attachment Improvement  
Item 6. Prestolite Service Bulletin No. ASM-5

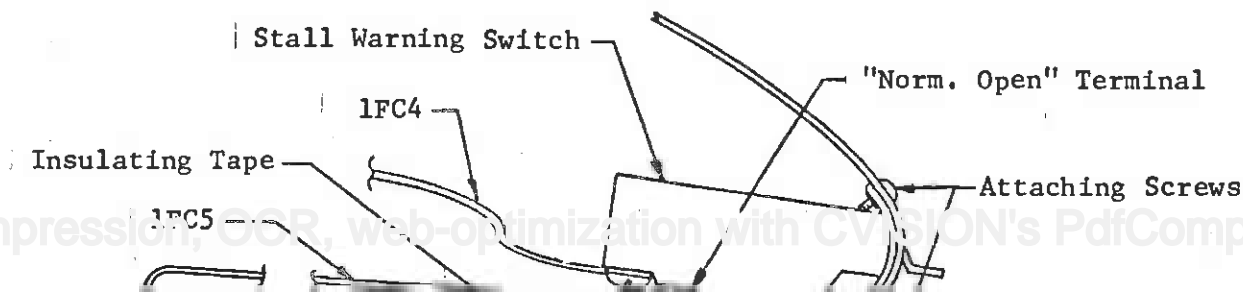
Relocation Instructions (Figure 1.)

The stall warning switch is installed in the model AA-1A wing such that flexing of the lower wing skin could cause intermittent contact of the normally open switch terminal to the inside of the wing skin resulting in a premature stall warning indication.

To eliminate this possibility, it is recommended that at the next scheduled inspection or sooner at the owner's discretion, the leads on the stall warning switch be reversed so that the 1FC5 ground wire terminal is connected to the "norm open" switch terminal per the following instructions:

1. Remove right wing tip.
2. Mark exact position of stall warning switch and vane in relation to wing leading edge.
3. Remove switch from wing by removing screws that secure switch bracket to wing skin.
4. Reverse 1FC4 and 1FC5 wires on switch terminals so that 1FC5 is connected to "norm open" terminal as shown in Figure 1.
5. Confirm satisfactory condition of insulating tape on inside wing skin.
6. Install switch in exact same position as removed. Install wing tip.

If switch is not relocated in exact same position as removed, the aircraft must be flight tested to confirm that stall warning horn sounds at 5-10 mph above stall speed at gross weight flaps up and flaps down.

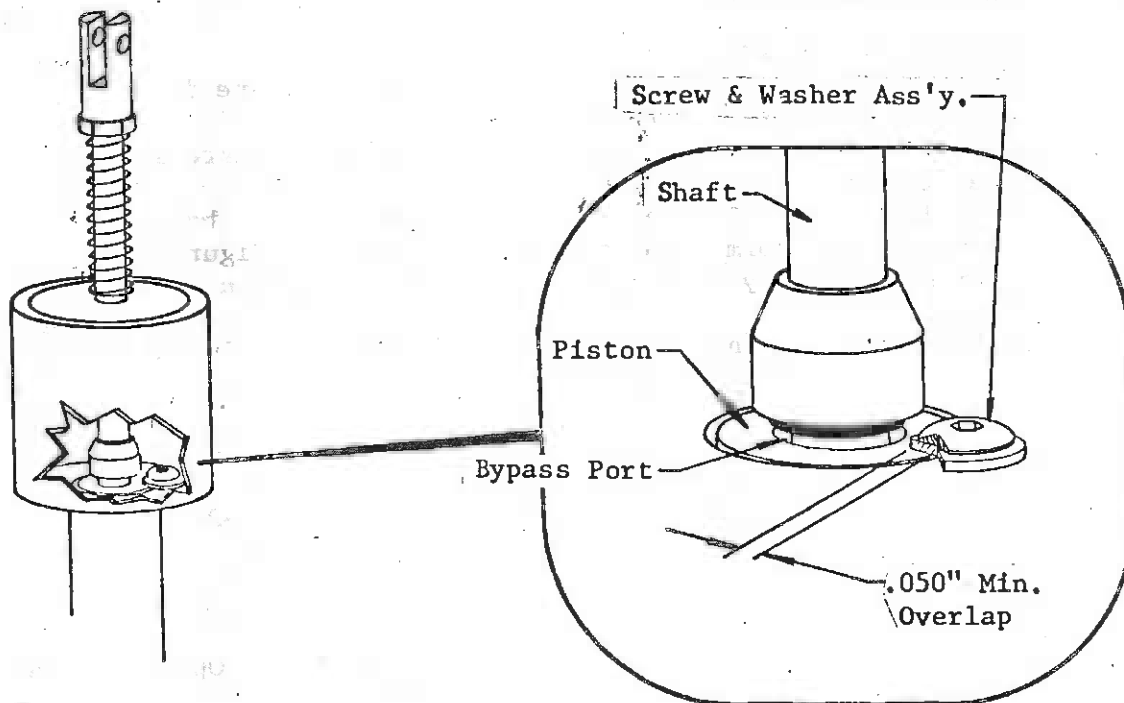
Figure 2. Master Cylinder

A few field reports of intermittent locking of a brake on the pilot's side of the aircraft have been received. The reports indicate that the brakes will operate normally for an extended period of time, but occasionally one wheel may lock for no apparent reason, particularly after several rapid applications of brakes such as "pumping" the brake pedal.

A cause for this intermittent brake locking has been traced to a slightly mislocated Gerdes part no. A-087-A screw and washer assembly which acts as an up travel stop for the piston and opens the bypass port between the piston and shaft when brake pedal pressure is released. Mislocation of the screw and washer assembly too far from the cylinder bore could result in insufficient washer overlap on the piston which could allow the piston to occasionally slip by the washer, and not open the bypass port, causing that brake to lock or drag.

Note that this possible defect applies only to the reservoir type master cylinders installed on the pilot's side of the aircraft and does not affect the co-pilot's side.

If intermittent brake locking is experienced, the cause should be determined as quickly as possible. Cylinders that do not have proper washer overlap per Figure 2, should be removed from service immediately and replaced with new cylinders part no. 403010-3.

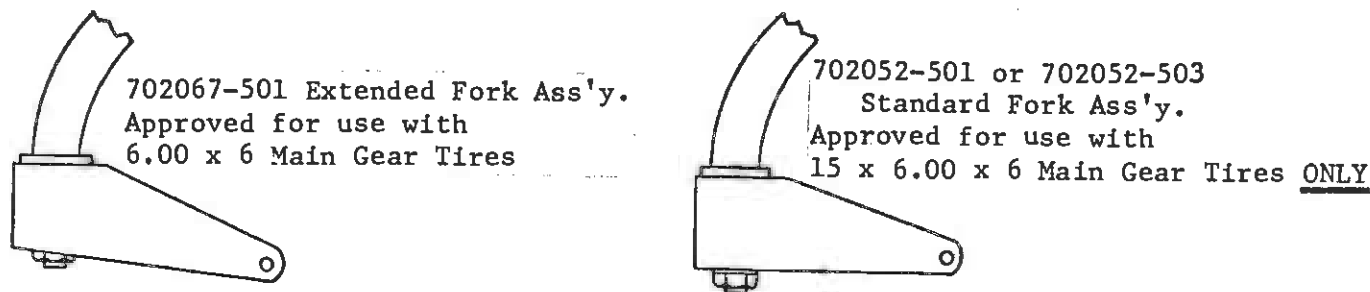
Figure 3. Nose Gear Fork

It has come to our attention that some model AA-1 and AA-1A have been improperly modified in the field when replacing the factory installed 15 x 6.00 x 6 main gear tires and tubes with 6.00 x 6 tires and tubes. Those modifications have been accomplished without installing the extended nose gear fork assembly part no. 702067-501 in place of the original factory installed part no. 702052-501 or 702052-503 fork assembly as called out in Accessory Kit No. AK-120.

Failure to install part no. 702067-501 extended fork assembly when installing 6.00 x 6 main gear tires, results in reduced propeller clearance and is not approved. We cannot be responsible for any aircraft operated in this condition. Figure 3 below illustrates the different fork assemblies to assist you in identifying these components.

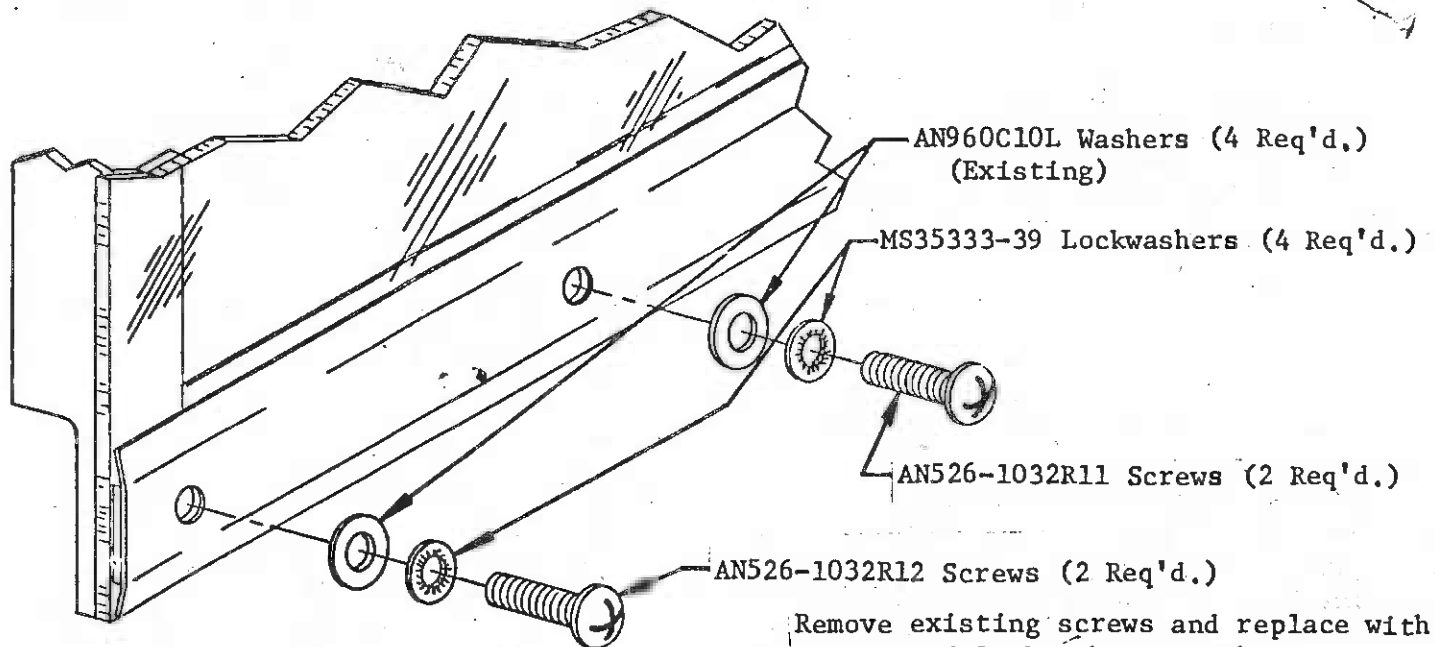
The above aircraft were produced with AN526-1032R10 screws installed in the four lower forward canopy/track attachment holes. These screws were secured to the stainless steel reinforcement inside the canopy track with Loctite.

To prevent possible cracking of the canopy as a result of the Loctited screws loosening in service, it is recommended that the screws on the above affected aircraft be inspected for security within the next 10 hours of operation. If the screws are found loose, they should be replaced with the improved hardware shown in Figure 4.

It is further recommended that the original hardware be replaced per Figure 4 regardless of condition, at the next interval of maintenance that requires canopy removal for cleaning and identification of the tracks.
