SUBJECT: Cabin Floor Inspection and Modification

SERIALS AFFECTED: AA1-0001 thru AA1-0457
AALA-0001 thru AALA-0123

AMERICAN AVIATION CORPORATION

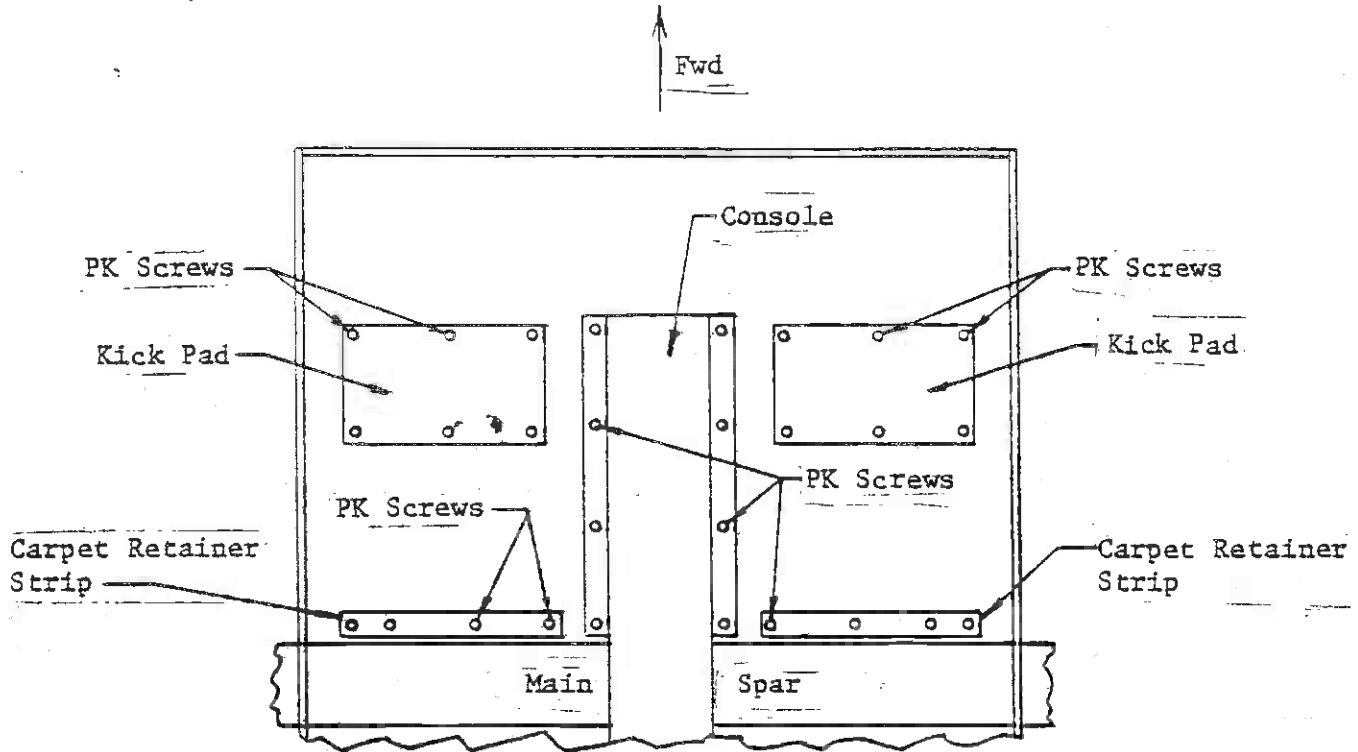
Figure 1. PK Screw Locations

Field reports have indicated that on some aircraft, minor delamination of the honeycomb cabin floor bottom skin has occurred. Investigation has revealed the cause to be water ingestion around the PK screws which attach the kick pads, console and carpet retaining strips to the floor. If the accumulated water freezes, minor delamination of the honeycomb bottom skin may result. Drilling the PK screw holes completely through the bottom skin eliminates the possibility.

It is recommended all PK screws in the cabin floor forward of the main spar (Figure 1) be removed, one at a time, and the holes be drilled through the bottom skin from the top using a #40 (.098") drill. This will allow any water entering around the PK screws to drain. After drilling each hole through bottom skin, reinstall the PK screw before proceeding to next screw. This will help maintain alignment and prevent possible enlargement of the screw holes. After all screw holes have been drilled through bottom skin, insert the shank end of the #40 drill in the hole from underneath and push drill aft to provide a lip on the forward edge of hole. (See Figure 2).
