SERVICE LETTER NO. 71-7

DATE: July 19, 1971
SUBJECT: Rudder/Elevator Rib Rivnut Inspection
SERIAL AFFECTED: AA1-0001 thru AA1-0458, AA1A-0001 thru AA1A-0239
TIME OF COMPLIANCE: At each scheduled inspection.

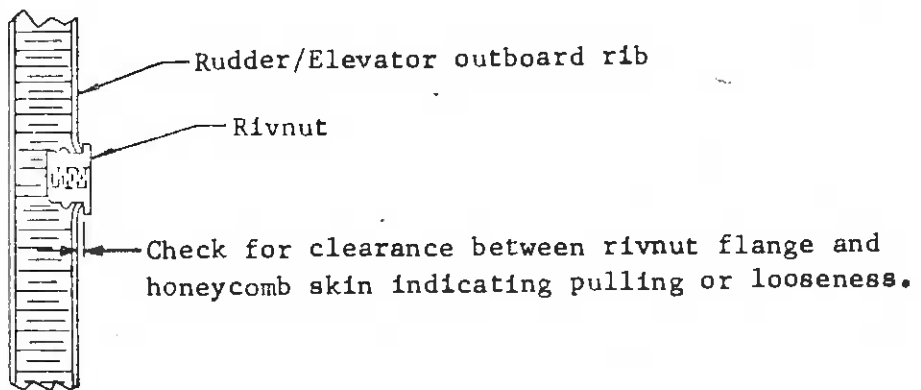
Figure 1. Rudder/Elevator Rivnut Inspection

It has come to our attention that on some aircraft, the rivnut in the elevator outboard rib and rudder top rib, which secures the aft end of the tip support rib, has pulled out or become loose.

At each scheduled inspection, it is recommended that the elevator/rudder tip be inspected for looseness. If looseness is noted, remove the elevator/rudder tip and tip-to-elevator rib assemblies and inspect the rivnut in the outboard/top rib for security of installation. Evidence of pulling will be indicated by clearance between the rivnut flange and the honeycomb skin (See Figure 1.)

If rivnuts are found to be loose or pulled, Service Kit No. SK-111 (Rudder/Elevator Tip Rib Modification), should be incorporated. Service Kit No. SK-111 includes all the necessary materials and complete instructions for making the modification and is available from your authorized American Aviation Corporation Dealer at no charge until March 1, 1972. Thereafter, the kit will be available at a cost of \$.63 (H). One kit is required for each control surface being repaired.
