SERVICE LETTER NO. 74-4

DATE: MAY 8, 1974

SUBJECTS: ITEM 1. WINDSHIELD/CANOPY ATTACH SCREW TORQUE
ITEM 2. CANOPY LATCH IMPROVEMENT
ITEM 3. CARBURETOR HEAT/MIXTURE CONTROL FITTING IMPROVEMENT
(SUPERSEDES SL71-10)
ITEM 4. FUEL TANK VENT INSPECTION AND MODIFICATION
ITEM 5. INSPECTION COVER INSTALLATION
ITEM 6. AVCO LYCOMING SERVICE INSTRUCTION NO. 1266

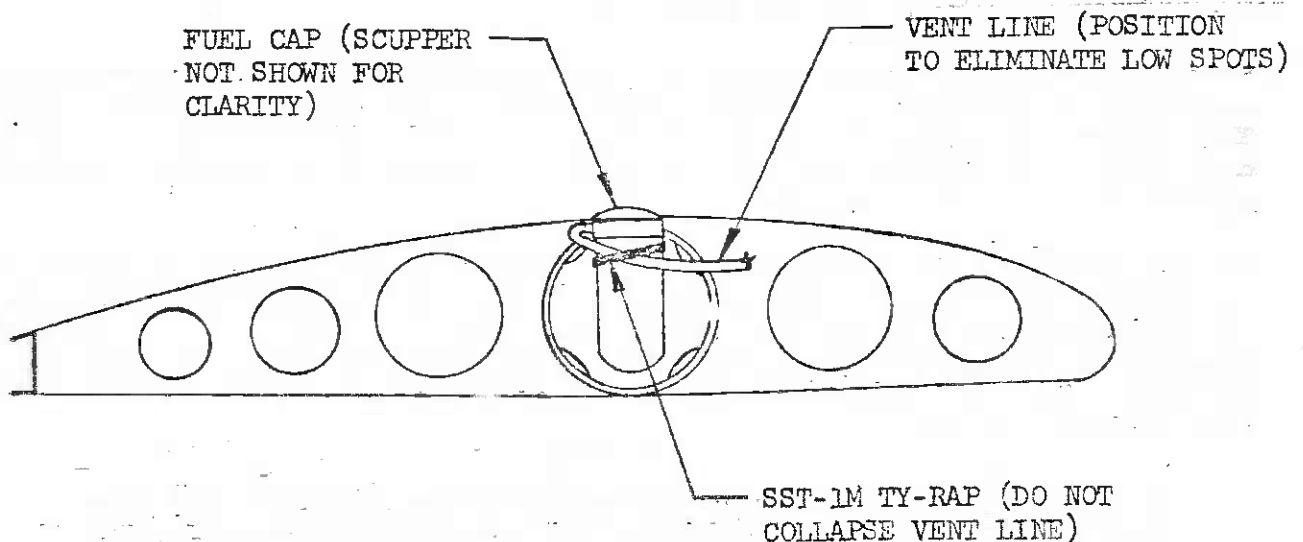
FIGURE 1. FUEL TANK VENT INSPECTION AND MODIFICATION

To preclude the possibility of an accumulation of moisture and subsequent freezing in a low spot in the right-hand wing outboard vent line, the following inspection should be performed within the compliance time suggested.

See Figure 1 for Ty-rap location.

Remove the right-hand wing tip and note the PVC vent line that connects to the fuel tank filler neck and the tube leading to the vent drain. If a low spot exists in this line, or if due to sagging, a low spot could develop, the line should be secured to the tank filler neck with part number, SST-1M Ty-rap or equivalent. The Ty-rap should support the vent line to prevent low spots, however, the Ty-rap should not be tightened to such an extent that the vent line will collapse.

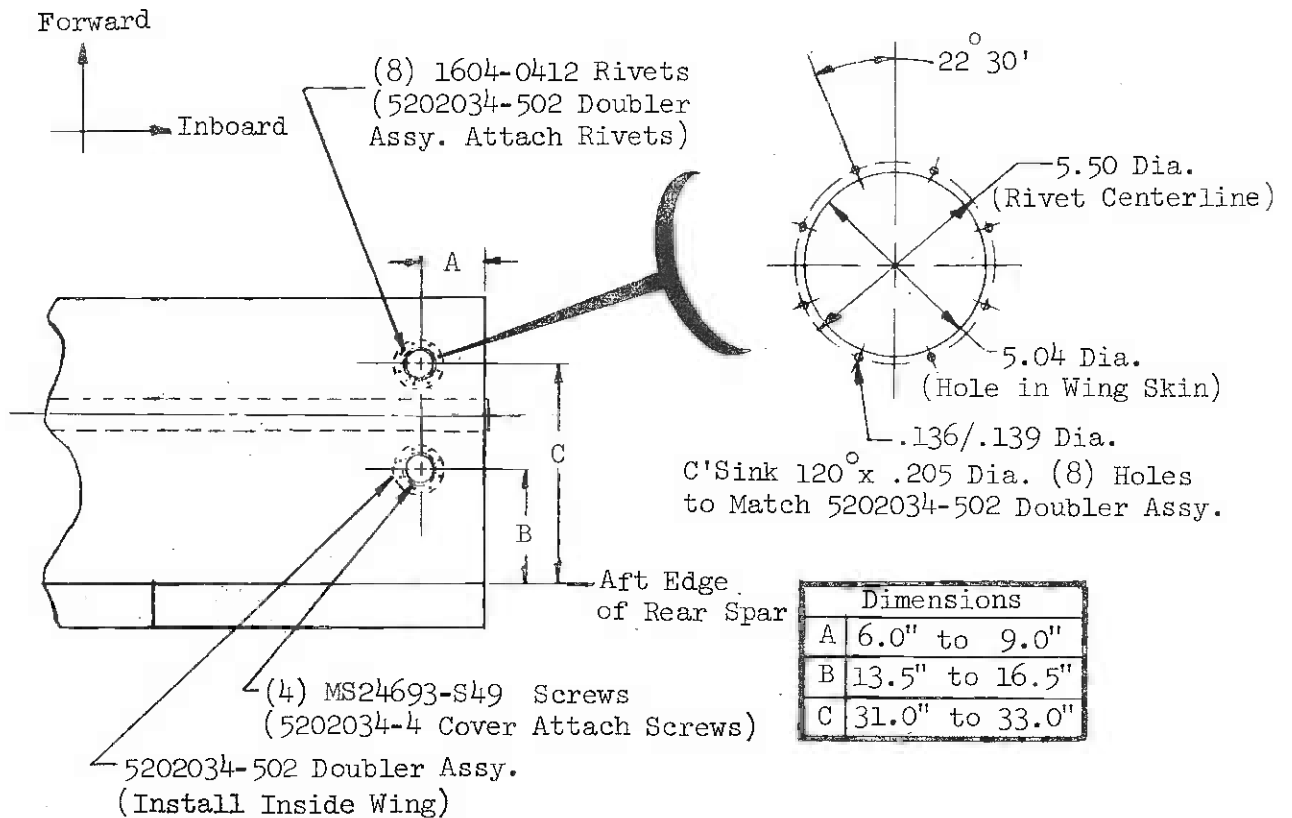
FIGURE 2. INSPECTION COVER INSTALLATION
(BOTTOM VIEW OF RH WING SHOWN)

Installation details are shown in Figure 2.

Access to the four wing lock bolts and fuel outlet fittings may be improved by the installation of an access cover and associated doubler below each wing lock bolt on the lower surface of each wing. This installation will provide a 4" diameter hole, which simplifies inspection of the wing lock bolt torque and facilitates the wing removal and installation procedure. The following items are required for the installation of four (4) access covers (two (2) per wing): four (4) 5202034-4 Cover; four (4) 5202034-502 Doubler Assembly; sixteen (16) MS24693-S49 Screw; (32) 1604-0412 Rivet.
