SERVICE LETTER NO. 74-5

DATE: MAY 9, 1974

SUBJECTS: ITEM 1. CANOPY LOCK SEALING
 ITEM 2. FUEL TANK ACCESS COVER IMPROVEMENT
 ITEM 3. CARBURETOR AIRBOX BEARING REPLACEMENT
 ITEM 4. WIRE BUNDLE PROTECTION

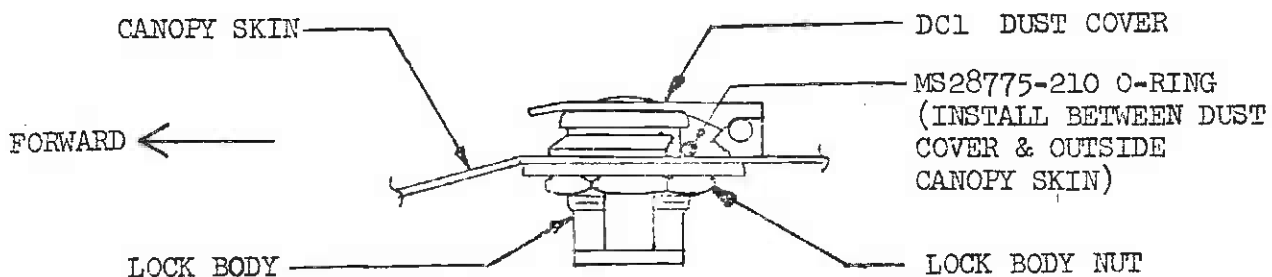
FIGURE 1. CANOPY LOCK SEALING

Since the issuance of Service Letter No. 72-3 (ITEM 4. Canopy Latch and Lock Sealing Improvements), dated August 7, 1972, an improved lock dust cover and associated o-ring have been incorporated. The installation of one or both items, as indicated below, will prevent water seepage through and around the lock.

Aircraft serials AA5-0001 through AA5-0440 require the installation of both items: Dust Cover, part number DC1; and O-Ring, part number MS28775-210. Aircraft serials AA5-0441 through AA5-0539 require the O-Ring only, part number MS28775-210.

Installation of the Dust Cover and/or the O-Ring necessitates removal of the outside canopy handle, Royalite trim panels surrounding the canopy latch box and the screws and rivets that attach the latch box assembly to the canopy. By pulling the latch box assembly out of the canopy, access to the lock body nut may be gained. After removing the nut and lock body, discard the existing dust cover and seal, install the improved dust cover and/or O-Ring and reassemble. Four (4) Rivets, part number 1604-0412, are required to reassemble the latch box assembly to the canopy.

See Figure 1 for dust cover and o-ring location.
