SERVICE LETTER NO. 75-10  
"FAA DOA EA-4 APPROVED"

DATE: November 17, 1975

SUBJECT: PARKING BRAKE IMPROVEMENT

SERIALS AFFECTED: All Model AA-1, AA-1A and AA-5, AA1B-0001 thru AA1B-0582, AA5A-0001 thru AA5A-0058 and AA5B-0001 thru AA5B-0179.

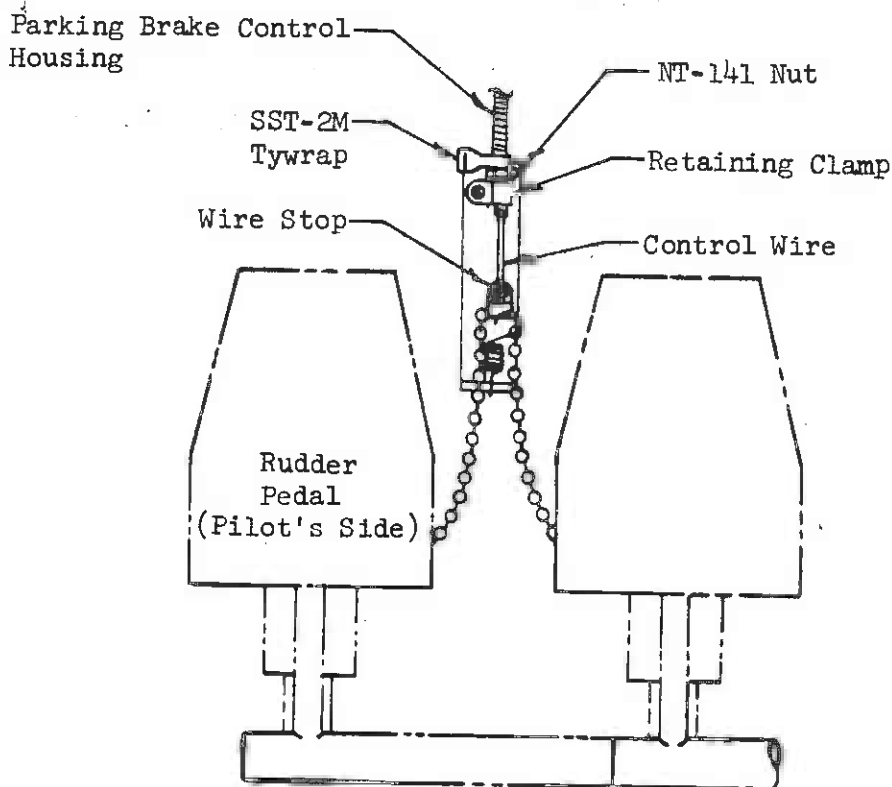
Figure 1. Parking Brake Improvement

Recent production aircraft have incorporated an engineering change that provides for increased retention of the parking brake control housing. Field reports indicate that in some instances, the housing would slip through the retaining clamp, when the parking brake control was actuated. Therefore, a nut and associated tywrap lock have been added directly above the clamp.

1. Loosen screw on wire stop, straighten parking brake control wire and remove wire stop.

2. Loosen retaining clamp sufficiently to allow the housing to slide through.
3. Install NT-141 Nut on housing, reassemble in the reverse order and rig parking brake.

4. Seat NT-141 Nut on retaining clamp and install SST-2M Tywrap to prevent nut from turning.
5. Check parking brake for proper operation. After disengaging, apply full rudder pedal deflection in both directions and confirm that neither master cylinder parking brake lever is lifting.
