SUBJECT: FLAP BONDLINE INSPECTION

SERIALS AFFECTED: AA5-0600 thru AA5-0834, AA5A-0001 thru AA5A-0013, AA5A-0015 thru AA5A-0017, AA5B-0001 thru AA5B-0118, AA5B-0120, AA5B-0123, AA5B-0124 and AA5B-0132.

TIME OF COMPLIANCE: Within 25 hours of operation, or 60 days, whichever occurs first.

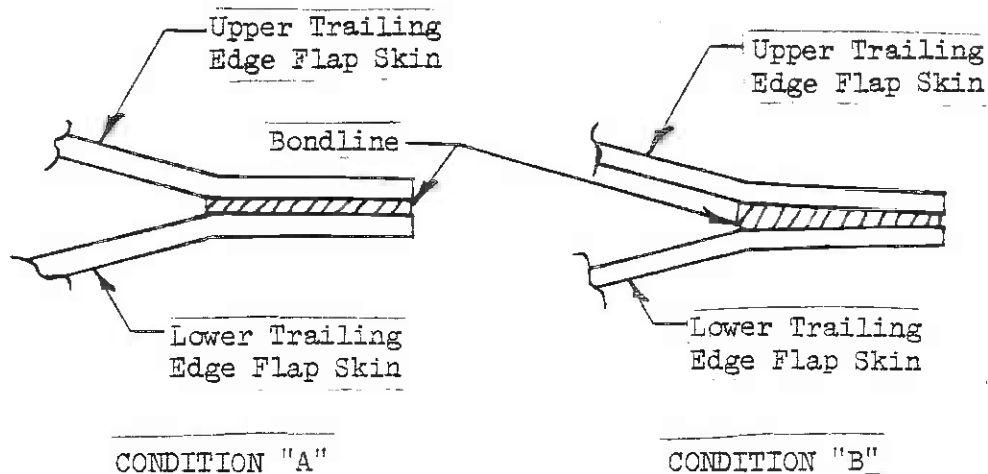
Figure 1. Flap Bondline Inspection

Field reports indicate that on some of the above aircraft serials affected, the flap trailing edge may be susceptible to partial bondline separation, if the upper and lower flap skins are not parallel in the area of the bondline.

View the inboard and outboard edges of both flaps. If inspection shows condition "A"; i. e., upper and lower trailing edge flap skins are parallel, no further action is required. If inspection shows condition "B"; i. e., upper and lower trailing edge flap skins are not parallel, perform the inspection steps listed below:

1. Carefully scan the flap trailing edge in a well lighted hangar or outside in daylight to determine the existence of hairline cracks between the two layers of bonded metal. Identify the location of any cracks with a grease pencil.

2. Gently tap the bondline with a coin or similar metal object to verify the existence of a bondline separation. Slowly move along the bondline, while tapping, and listen for a change in tone as the suspect area is traversed. A bondline separation will produce a flat or hollow sound when "tapped" directly in the damaged area.

3. If the results are questionable, attempt to insert a .004" to .006" feeler gauge into the bondline to verify that a separation exists.
4. If the results of inspection steps "2" and "3" are negative, install two (2) NAS1097-AD3-2 Rivets in each affected flap as shown in Figure 2. If the results of either "2" or "3" are positive, order Service Kit No. SK-125 and make the repairs accordingly.

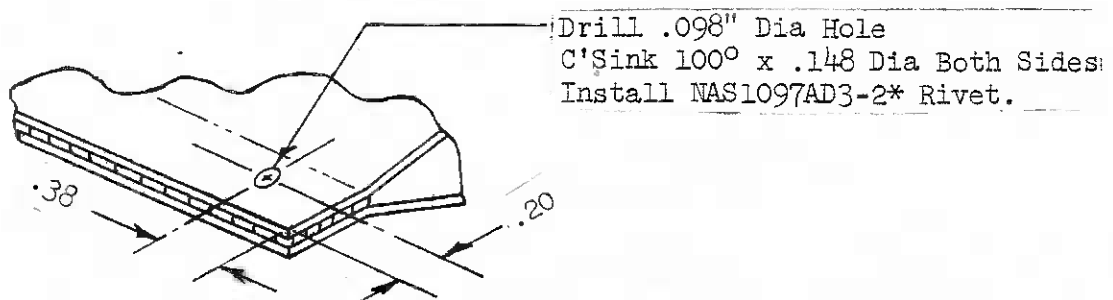
Figure 2. Rivet Installation  
(Typical, inboard and outboard edges of  
both flaps).

\* MS20426AD3-2 Rivet is alternate.
