DATE: May 24, 1977

SUBJECT: MAGNETO LEAD ISOLATION AND ROUTING

MODELS AFFECTED: All Models

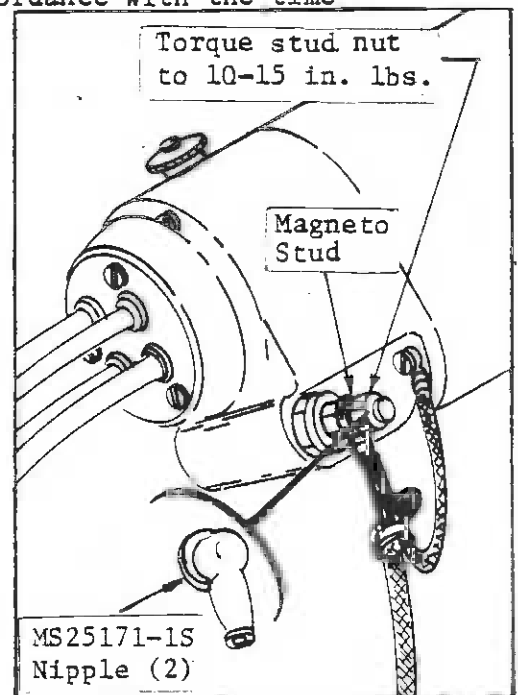
(FIGURE 1.)

It has been reported that during a routine inspection, the "P" lead shielding, which is attached to the magneto housing, was found improperly routed and insulated which provides the possibility for it to contact the magneto stud causing a dead magneto.

1. Generally inspect the condition and security of the "P" lead and ground shielding.
- Be certain the nipple (Part No. MS25171-1S) is in place over the magneto stud and the shrink tubing is in place on the "P" lead over the point where the shielding is pulled back.
3. The "P" lead must be in a position that causes the shielding to be routed around the magneto stud instead of across the top.
 4. The shielding pigtail on the magneto lead must be pulled back, looped and secured in place with a tywrap (Part No. SST-2M) or equivalent. The loop must be outside the nipple.
