SERVICE LETTER No. 93-1

DATE: FEBRUARY 9, 1993  
 SUBJECT: OUTBOARD BEARING BRACKET ASSEMBLY  
 MODELS AFFECTED: AA-5, AA-5A, AA-5B  
 TIME OF COMPLIANCE: NONE - PROVIDED FOR INFORMATION ONLY

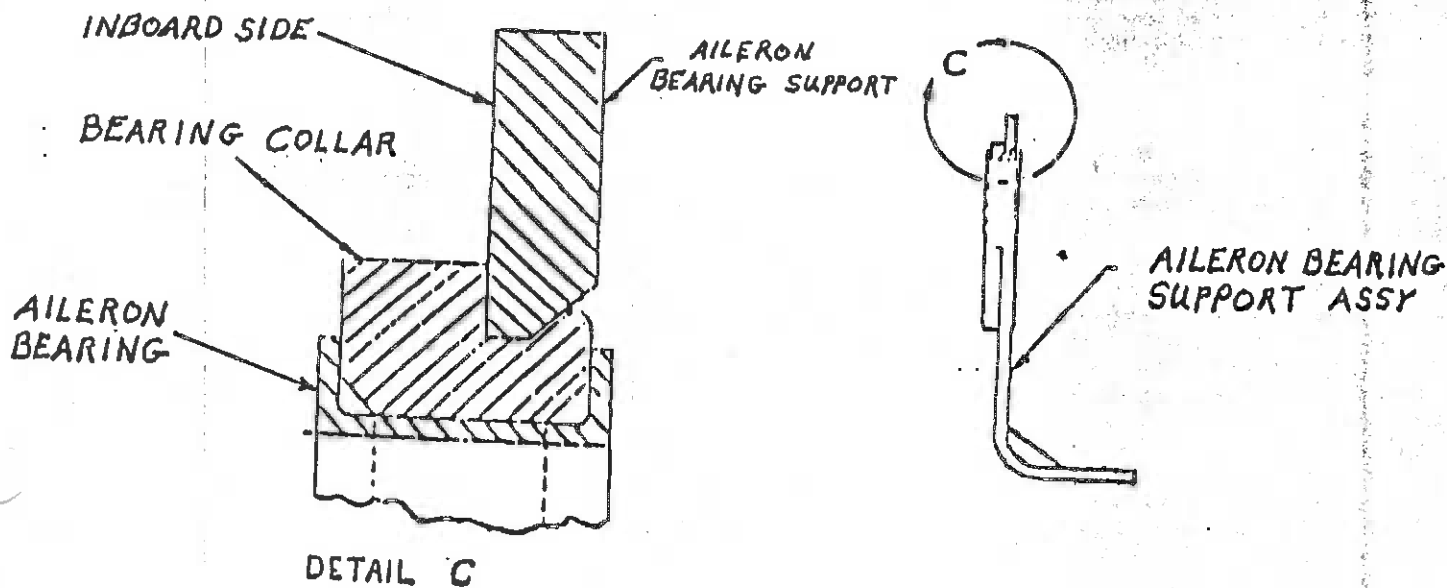
We have received reports that there has been some confusion concerning the outboard aileron bearing support brackets. The aileron bearing support assembly as shown in the AA-5 Series Illustrated Parts Catalog is P/N 902010-501. This bearing bracket assembly underwent an engineering change dated 5-12-78 and was issued a new part number, 902010-504. This change was not reflected in the latest revision of the AA-5 Series Illustrated Parts Catalog or the AA-5 Series Maintenance Manual dated June 1, 1983. Both parts are considered to be serviceable, however, when replacement of the outboard aileron bearing bracket assembly is necessary, the -504 assembly with the collar on the inboard side should be installed and shimmed as required to obtain the specified aileron end play.
