SERVICE LETTER

SL 2003-3
ATA 5711

SUBJECT: **OUTBOARD WING SPAR ATTACH BOLTS**

MODEL / SERIALS AFFECTED: AG-5B S/N 10203, 10204, 10207 and S/N 10209 through 10215

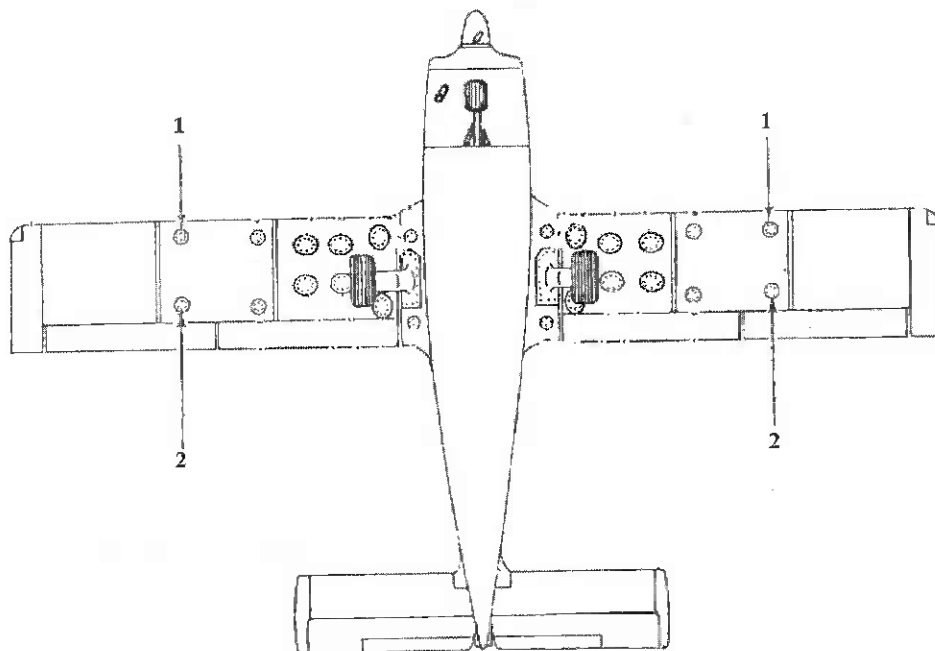
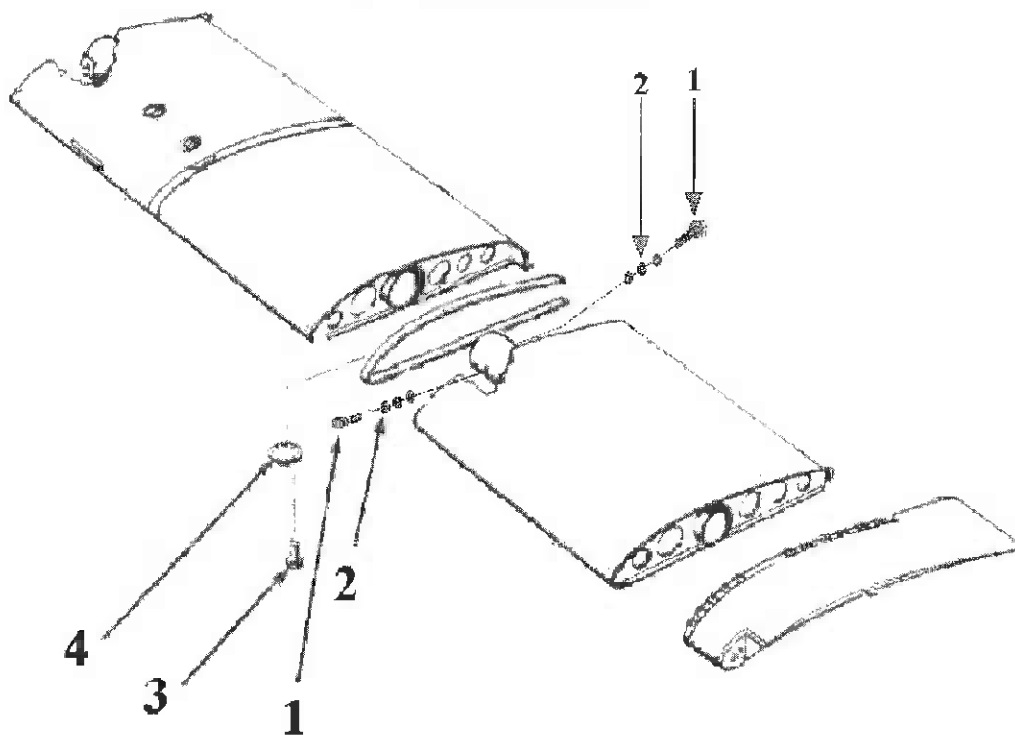
Figure 1

1. Forward Access Panels
2. Aft Access Panels

1. 901044-1 Shoulder Bolt or AN8-10A Bolt
2. AN960-616 Washer (3) or AN960-816 Washer (1)
3. Screw
4. Access panel

2. Remove the access panels forward and aft of the outboard spar attach point and locate the outboard spar attach bolts. (Figure 1)
3. Visually inspect the spar attach bolts and determine the bolt type. (Figure 3)

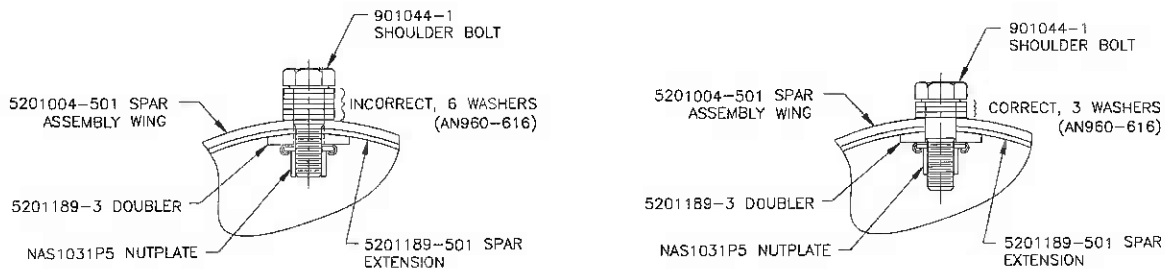
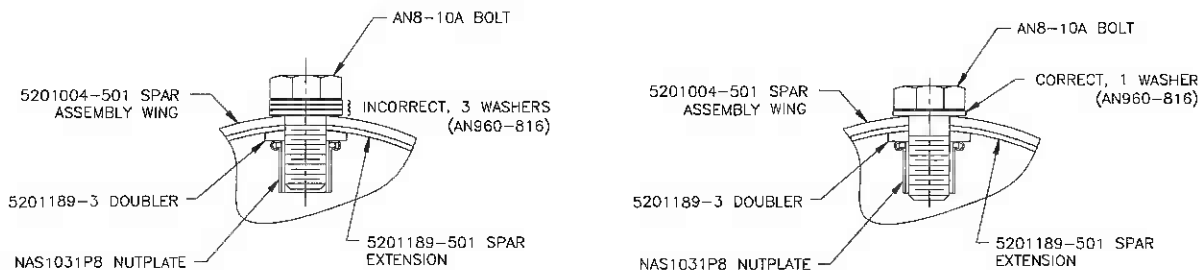
Figure 2

It has been determined that there is insufficient shoulder engagement of the outboard wing panel spar attach bolts on the affected aircraft due to an incorrect washer stack-up under the bolt head. This condition could lead to loosening of the bolts and possible damage to the bolts and/or bolt holes.

The standard method of attachment of the outboard wing panel is the use of two (2) P/N 901044-1 Shoulder Bolts, one on either side of the spar. These shoulder bolts should have three (3) AN960-616 washers under the head of each bolt. It has been determined that six (6) washers may have been installed under the head of each Shoulder Bolt during the manufacturing process. (Figure 2)

One or both wings installed on the affected aircraft may have their outboard wing panels attached using an alternate method of attachment. This method uses two (2) AN8-10A bolts with one (1) AN960-816 washer each in the place of the 901044-1 bolts and AN960-616 washers. It has been determined that three (3) AN 960-816 washers may have been installed under the head of these bolts during the manufacturing process. (Figure 2)

4. If 901044-1 shoulder bolts are found, determine the number of AN960-616 washers installed under the head of each bolt.
 - a. If three (3) washers are installed under the head of each bolt (Figure 2), no further action is required. Comply with steps 12-14.

- b. If six (6) washers are installed under the head of each bolt (Figure 2), proceed with steps 6-14.
5. If AN8-10A bolts are found, determine the number of AN960-816 washers installed under the head of each bolt.

- a. If one (1) washer is installed, no action is required. Comply with steps 12-14.
 - b. If three (3) washers are installed under the head of the bolt (Figure 2), proceed with steps 6-14.

9. Reinstall the 901044-1 shoulder bolts with three (3) AN960-616 washers under the head of each bolt and torque to 60-85 inch pounds.
10. Reinstall the AN8-10A bolts with one (1) AN960-816 washer under the head of each bolt and torque to 290-410 inch pounds.
