**Gulfstream American**

SERVICE BULLETIN NO. 120

**DATE:** October 7, 1970  
**TO:** Owners and Operators of Yankee Aircraft  
**SUBJECT:** Throttle Control Inspection  
**MODELS AFFECTED:** AA1-0001 thru AA1-0436. All spares stock of part nos. 507002-1 and 507002-2 throttle control.  
**TIME OF COMPLIANCE:** Within 25 hours of operation or sooner at the owners discretion.

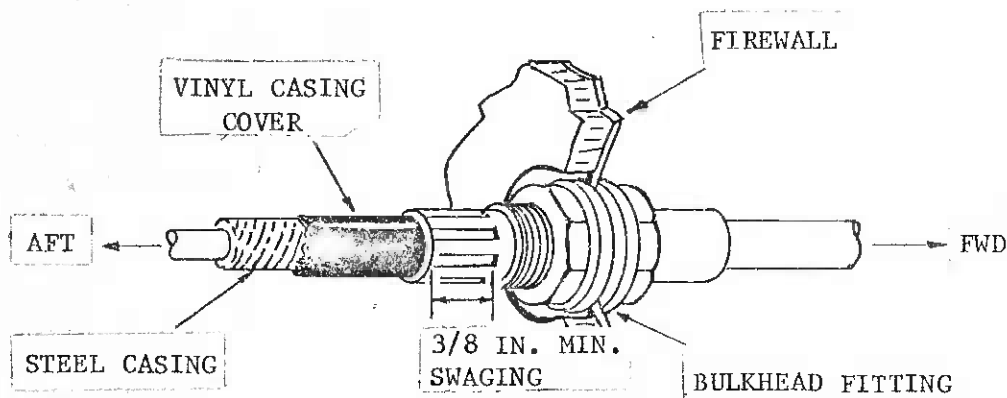
Figure 1. Throttle Control Bulkhead Fitting

It has come to our attention that some part nos. 507002-1 or 507002-2 throttle control assemblies may have been improperly swaged at the firewall bulkhead fitting. (see figure 1) Improper swaging of this assembly can result in separation of the outer casing from the bulkhead fitting and subsequent partial loss of throttle control due to the outer casing sliding out of the bulkhead fitting when the throttle is opened.

1. Remove right hand forward console panel and locate the point where the throttle control cable passes through the firewall.
2. Measure the length of the swaging marks on the aft end of the firewall bulkhead fitting as shown in figure 1. If the swaging is less than 3/8 inches the cable must be removed from service.
