DATE: February 23, 1972

SUBJECT: Fuel Tank Vent Line Inspection and Modification

SERIALS AFFECTED: AA5-0002 through AA5-0045

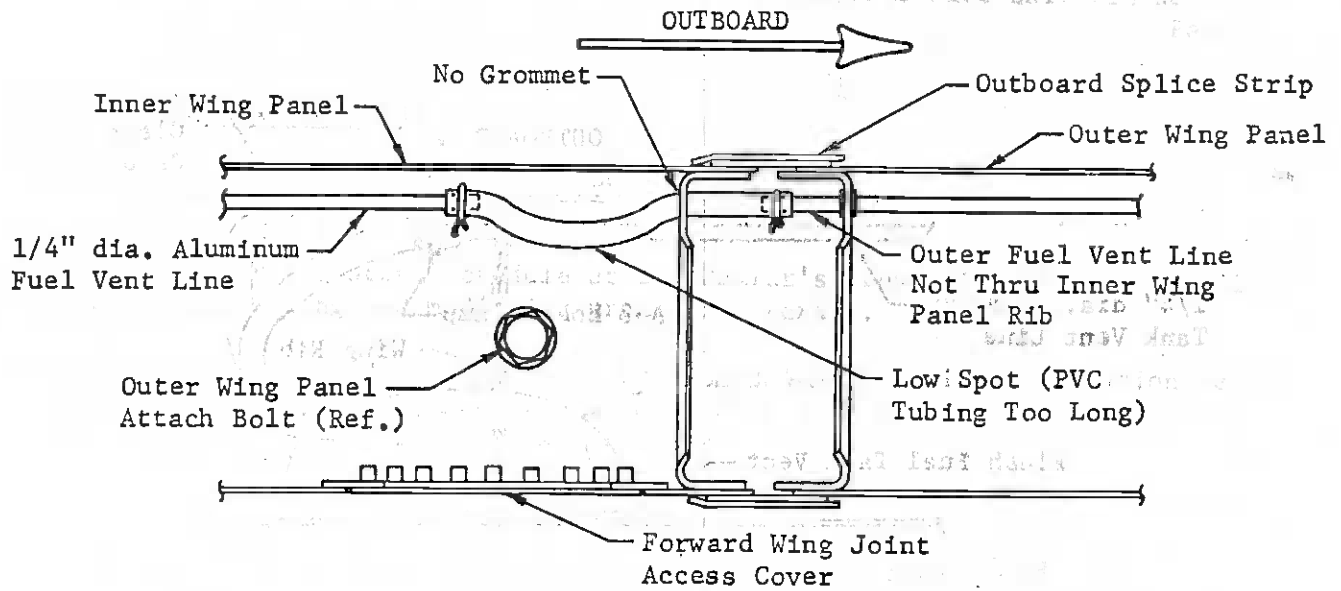
FIGURE 1A

Subsequent field reports indicate that some additional aircraft may have an additional low spot at the vent line junction between the inboard and outboard wing panels. This condition could cause fuel tank vent line blockage if enough water accumulated and froze in this low spot to completely close off the tube. This could lead to the collapse of a fuel tank and ultimately cause fuel starvation to the engine.

The fuel tank vent line connections to be inspected can be reached through inspection covers located approximately 5 1/2 ft. inboard from each wing tip and 1 ft. back from the wing leading edge on the wing lower surfaces. Some aircraft have vent line connections as shown in Figure 1A, where a long length (approximately 6") of PVC flexible tubing was used to make the connection with one clamp located between the two closely spaced wing ribs and the other clamp located directly over the inspection cover. No rubber grommets were used where the PVC tubing passed through the wing rib. This long length of PVC tubing can sag and cause a low spot if the outboard 1/4" dia. aluminum tank vent line is inadvertently moved inboard at any time. Any sag must be removed prior to further flight on any aircraft that will be operated in an OAT of less than 32°F. See below for modification instructions.

INCORRECT INSTALLATION
 View Looking Aft
 L.H. Wing (R.H. Opposite)

Aircraft that have the vent line splice joint configuration as shown in Fig. 1A must be modified to the joint shown in Fig. 1B. Any change in this joint requires

1. Remove existing long length of PVC tubing (Fig. 1A).
2. Install a rubber grommet part no. MS35489-6 in the wing rib hole that the PVC tubing passed through originally.
3. Slide a 2 1/2" long length of PVC tubing 1" onto the inboard vent line and clamp in place. (use a section of the original tubing removed in step 1)
4. Slide the hose clamp over the outboard tube and insert the aluminum tube into the PVC connection approximately 1" until a 1/2" gap exists between the ends of the aluminum tubes.
5. Install the clamp on the PVC tube completing the connection and replace the inspection cover.

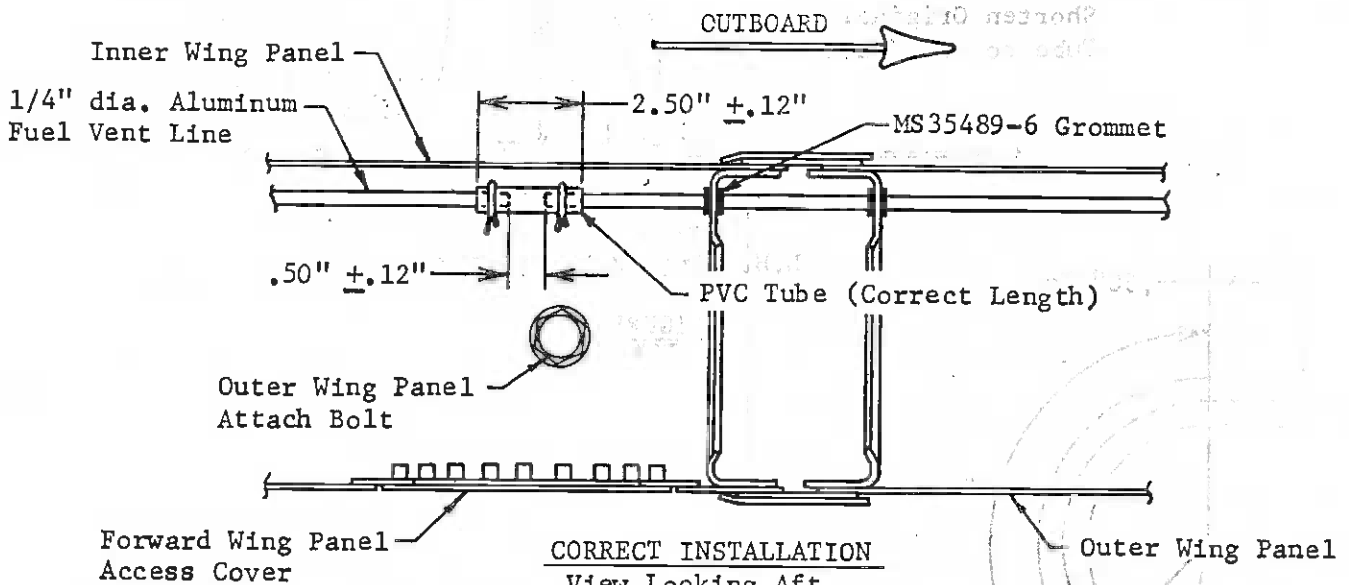
FIGURE 1B

CORRECT INSTALLATION
 View Looking Aft
 L.H. Wing (R.H. Opposite)

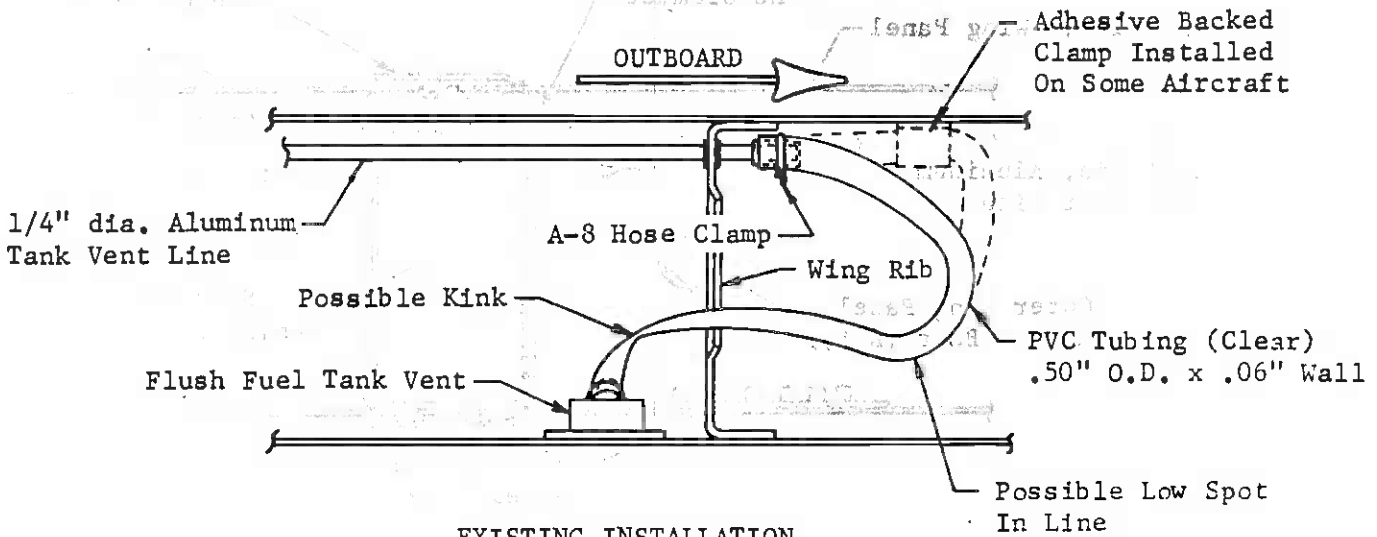
FIGURE 2A

Wire Bulletin No. 128, issued on February 16, 1972, described the procedure to inspect and remove any low spots or kinks in the PVC fuel tank vent line between the vent outlet housing and the outboard end of the 1/4" dia. aluminum tank vent line on some selected aircraft. (See Fig. 2A).

EXISTING INSTALLATION
 View Looking Aft
 L.H. Wing (R.H. Opposite)

The outboard vent line to vent housing PVC tubing connections must be modified per Fig. 2B as follows:

1. Verify that aircraft complies with modification No. 1 before starting this modification.
2. Remove both wing tips.
3. Disconnect the 1/2" dia. PVC tube and remove PVC spacer from 1/4" dia. aluminum tank vent line (upper connection). Some aircraft have an adhesive backed plastic clamp mounted to the upper wing skin supporting the existing loop in the PVC tube. This clamp should be removed from the aircraft.

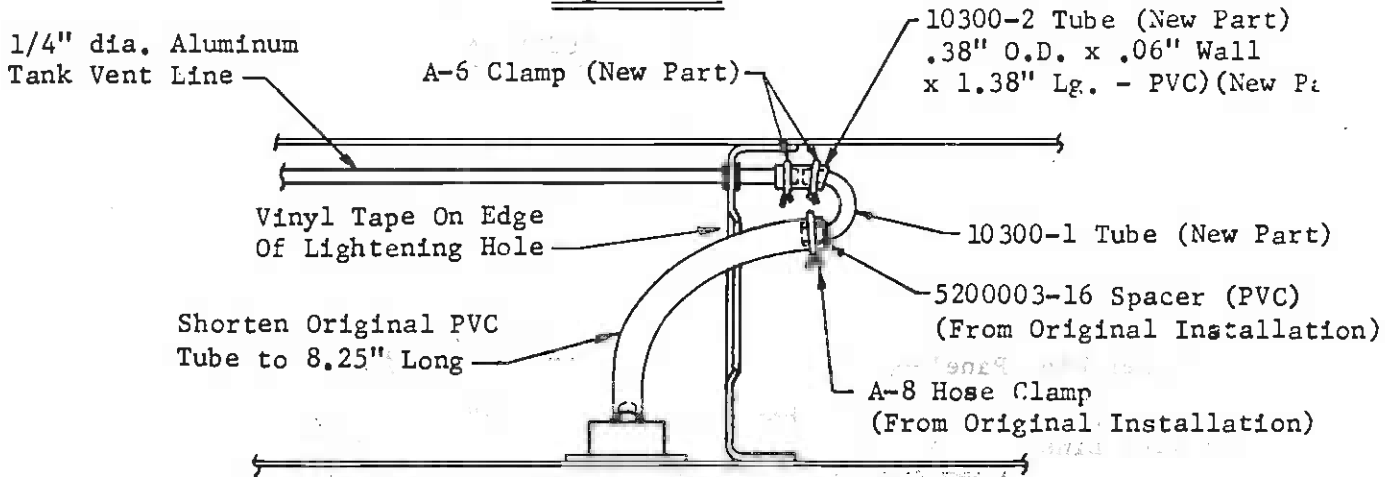
FIGURE 2B

MODIFIED INSTALLATION
 View Looking Aft
 L.H. Wing (R.H. Opposite)

4. Install the 1 3/8" long x 3/8" O.D. PVC tube (part no. 10300-2) and the 1/4" dia. aluminum tube 170° bend (part no. 10300-1) on the outboard end of the existing vent line per Fig 2B, using (2) #A-6 hose clamps (Corbin).

5. Shorten existing 1/2" O.D. PVC tube to approximately 8 1/4" long, insert #5200003-16 spacer (PVC) removed in step 3 and clamp to the 170° bend tube with #A-8 original hose clamp, being sure tube is properly positioned and is free of kinks.

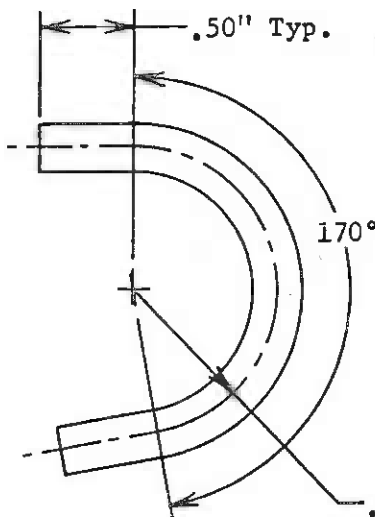
10300-1 Tube
 Mat'l. - .25" O.D. x .035" Wall,
 5052-0 Aluminum
