SERVICE BULLETIN NO. 152A
(SUPERCEDES SERVICE BULLETIN NO. 152
"FAA DOA EA-4 APPROVED")

SUBJECT: UPPER COWL CENTER HINGE REPLACEMENT

SERIALS AFFECTED: AA5-0641 thru AA5-0834, AA5A-0001 thru AA5A-0050,
AA5A-0054 thru AA5A-0056, AA5B-0001 thru AA5B-0169,
AA5B-0171 and AA5B-0180 thru AA5B-0183.

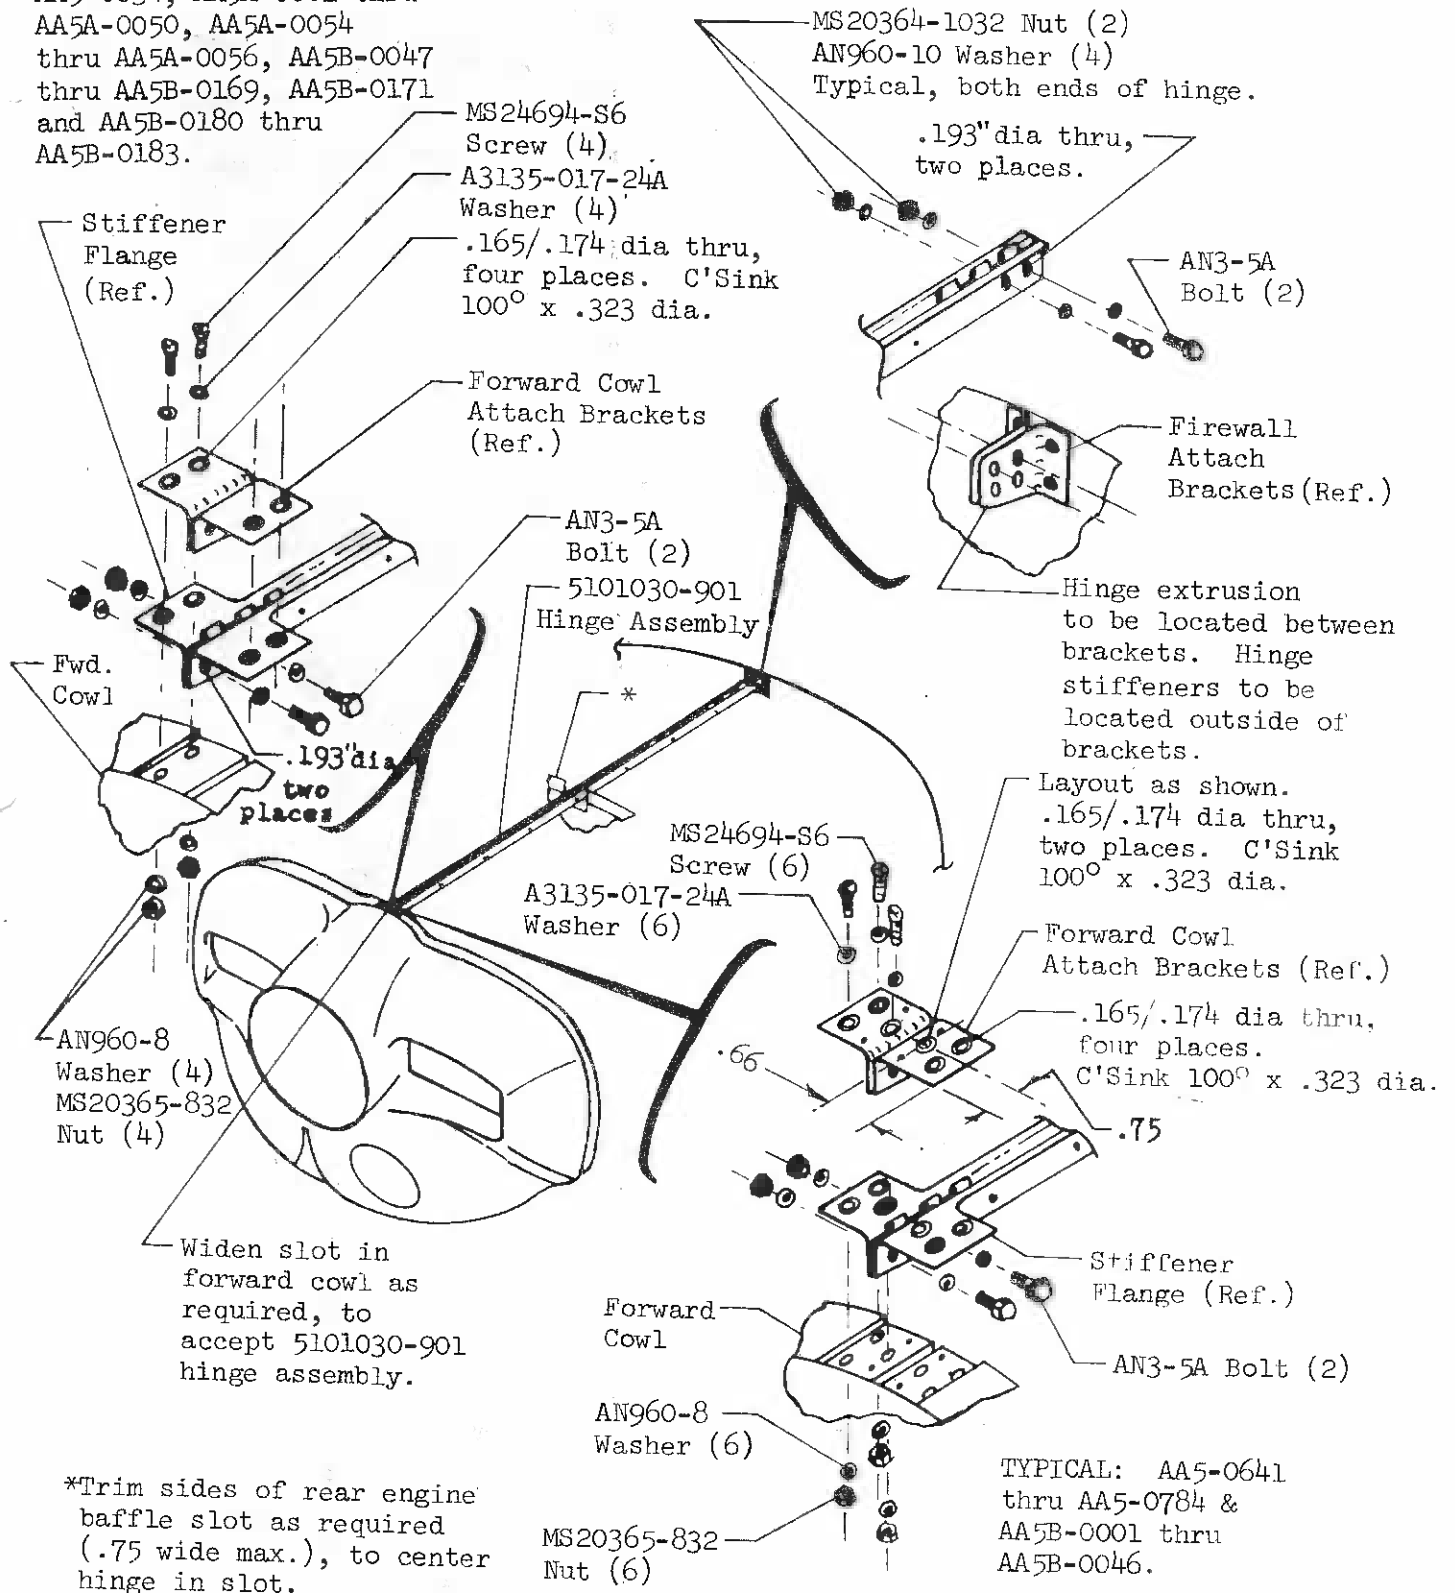
Figure 1. Upper Cowl Center Hinge Replacement

A few instances of upper cowl hinge assembly failures have recently been reported on the model AA-5B aircraft. Cracks develop at the center hinge adjacent to the forward and aft attach brackets and progress to failure unless detected by inspection.

TYPICAL: AA5-0785 thru
AA5-0834, AA5A-0001 thru
AA5A-0050, AA5A-0054
thru AA5A-0056, AA5B-0047
thru AA5B-0169, AA5B-0171
and AA5B-0180 thru
AA5B-0183.

1. Remove the upper cowl in accordance with the current model service manual.
2. Separate the original hinge assembly from the right and left upper cowl halves by removing the hinge pin.
3. The improved center hinge assembly is undrilled. The forward and aft attach bracket holes should be laid out from the original hinge. Holes should be drilled to .193".

5. Temporarily attach the forward attach brackets to the hinge assembly with the stiffeners outside of the brackets, utilizing the hardware shown in Figure 1.
6. Temporarily attach the hinge assembly to the firewall attach brackets with the stiffeners outside of the brackets utilizing the hardware shown in Figure 1.
7. On AA5-0641 thru AA5-0784 and AA5B-0001 thru AA5B-0046, match drill the forward stiffener flanges of the new hinge assembly to the two (2) existing outboard rivet holes already drilled in each of the attach brackets and forward cowl. Locate a third hole .75" from the leading edge and .66" from the outboard edge in each forward cowl attach bracket. Drill all six (6) holes to .165/.174 inch dia and countersink to 100° x .323 inch dia.

8. Remove hinge from aircraft and deburr all holes.
9. Permanently install the forward attach brackets to the new hinge assembly as stated in step 5.
10. Install left and right cowl halves to hinge assembly with hinge pin. Crimp the leading and trailing edges of hinge to retain pin.
11. On AA5-0641 thru AA5-0784 and AA5B-0001 thru AA5B-0046, attach the forward edge of the upper cowl assembly to the forward cowl assembly placing six (6) MS24694-S6 Screws and six (6) A3135-017-24A Washers through the attach bracket, hinge flange and forward cowl assembly and secure them with six (6) AN960-8 Washers and six (6) MS20365-832 Nuts.

12. Permanently install the new hinge assembly to the firewall attach brackets as stated in step 6.
13. Locate a slot in the aluminum rear engine baffle where the hinge passes through the baffle. Trim sides of slot as required (.75" max.) to center the hinge in the slot and to insure no contact is made between the hinge and baffle during start up and shutdown. Do not disturb baffle flexible seal.
