Service Bulletin No. 155
FAA DOA EA-4 Approved

SR125A

Subject: Bondline Protection

Serials Affected:	AA1, AA1A's	0001 & Sub.
	AA1B	0001 thru 0641
	AA5's	0001 & Sub.
	AA-5A	0001 thru 0173
		0176 thru 0196
	AA-5B	0001 thru 0309
		0311 thru 0324

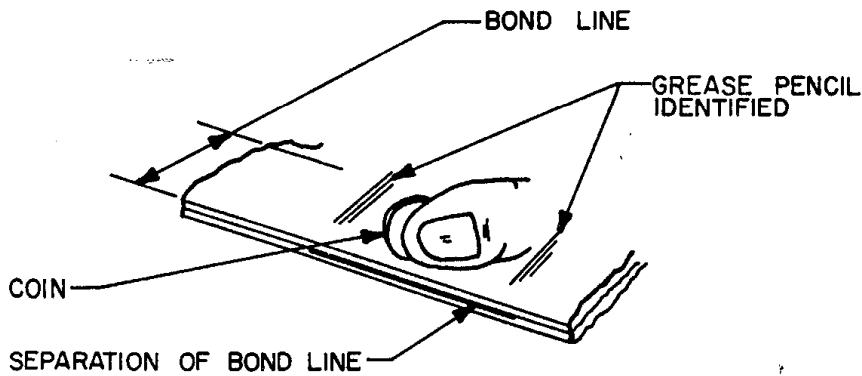
BOND LINE SEPARATION DETECTION METHOD

- A. Carefully scan the edges of all joints in a well lighted hangar or outside in daylight to determine the existence of hairline cracks between two layers of bonded metal. Figure 1 shows the appearance of this condition. Identify the location of any cracks with a grease pencil as shown in Figure 1.

- B. Gently tap the bondline with a coin or similar metal object to verify the existence of a bondline separation. Slowly move along the bondline, while tapping, and listen for a change in tone as the suspect area is traversed. A bondline separation will produce a flat or hollow sound when "tapped" directly in the damaged area.
