AIRCRAFT, LLC

## SERVICE BULLETIN

**SB-191**

**SUBJECT:** **Rear Seat Belt Attach Bracket**

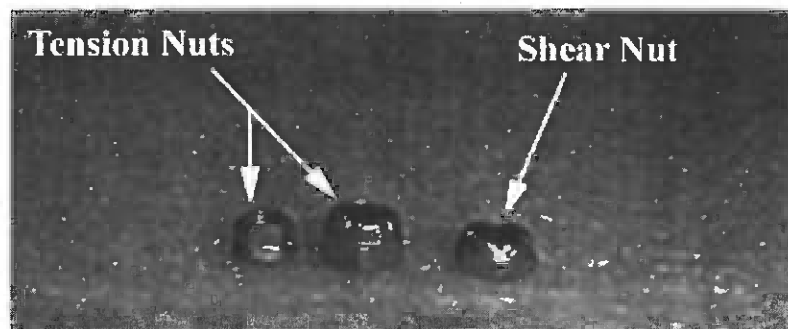
**Figure 1**

**NOTE: MS20365-1032, MS21044-N3 and MS21042-3 tension nuts are acceptable. Low profile shear nut such as MS20364-1032 or MS21083-N3 are not acceptable. See Figure 1.**

6. If the orientation of the seat belt bracket and -6 plate is not correct and/or incorrect nuts are found, accomplish the following:
  - (a) Remove nuts, washers and two AN3-5A bolts from the seat belt bracket and remove the bracket and -6 plate.
  - (b) Reinstall the bracket and -6 plate as shown in Figure 1. Make sure the -6 plate is positioned with the beveled edge nestled in the corner of the fuselage side panel and the bulkhead.
  - (c) Reattach the seat belt bracket using approved bolts, nuts and washers.
  - (d) Reattach the baggage floor carpet.
  - (e) Flip the rear seat bottom to its original position.
  - (f) Reinstall the rear seat back cushions.
  - (g) Record compliance in the aircraft log book.

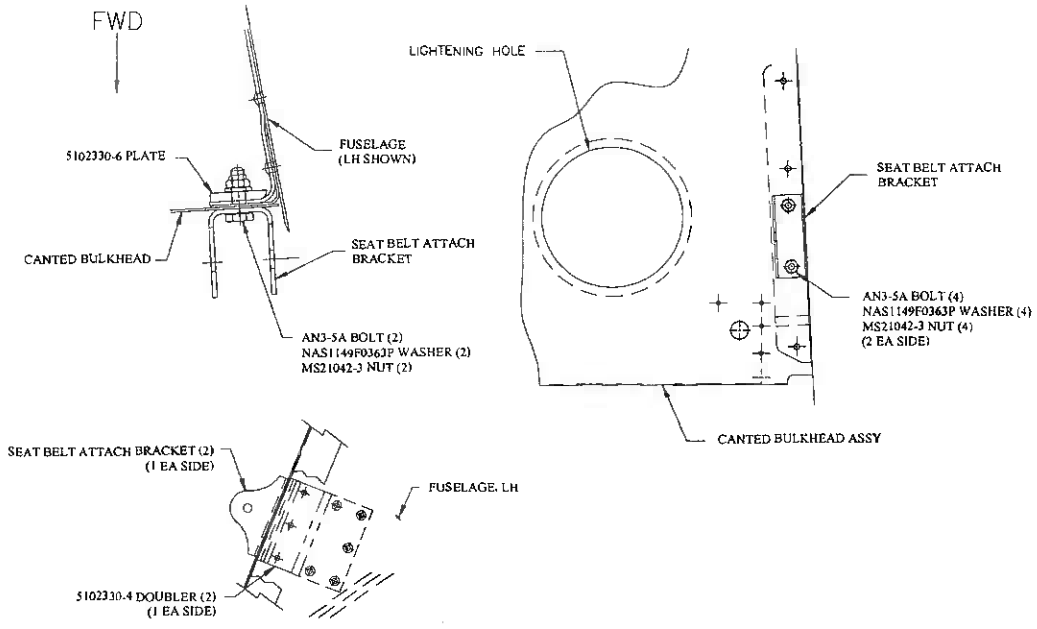
**Figure 2**

**CORRECT INSTALLATION**

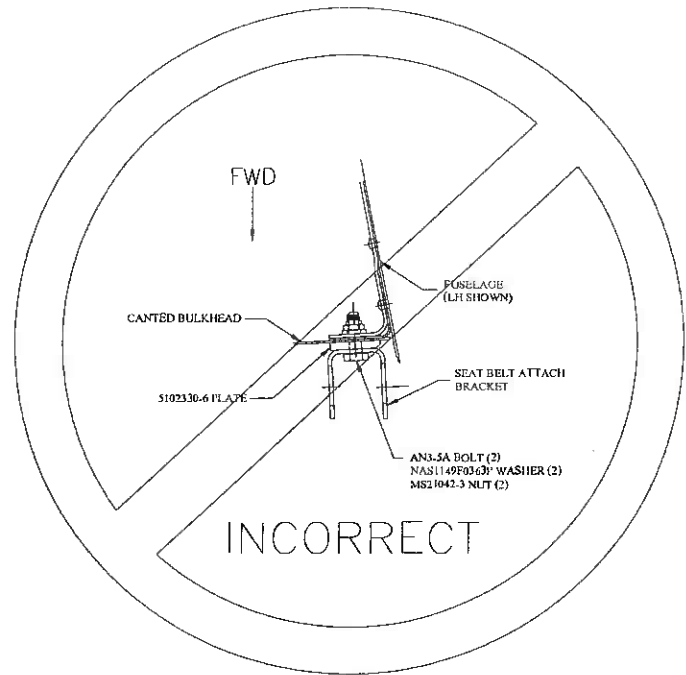
We have received reports of incorrect installation of the outboard rear seat belt attach brackets. In the cases reported, doubler plate P/N 5102330-6 was installed between the seat belt attach bracket and the bulkhead and incorrect nuts were used. This arrangement results in reduced seat belt attachment strength when compared to the approved configuration.

**NOTE: INCORRECT INSTALLATIONS WILL HAVE THE -6 PLATE ON THE FORWARD SIDE OF THE BULKHEAD AND/OR INCORRECT HARDWARE.**

**INCORRECT INSTALLATION**
