SERVICE LETTER NO. 74-6

SUBJECT: BUSS BAR/BEARING COLLAR CLEARANCE

SERIALS AFFECTED: AA1B-0238 thru AA1B-0296, AA1B-0298 thru AA1B-0318,
AA1B-0320 thru AA1B-0337, AA1B-0339 thru AA1B-0343,
AA1B-0345 thru AA1B-0356, AA1B-0358 thru AA1B-0376,
AA1B-0380, AA1B-0382 thru AA1B-0384, AA1B-0386 thru
AA1B-0388, AA1B-0391 and AA1B-0395.

GRUMMAN AMERICAN AVIATION CORPORATION

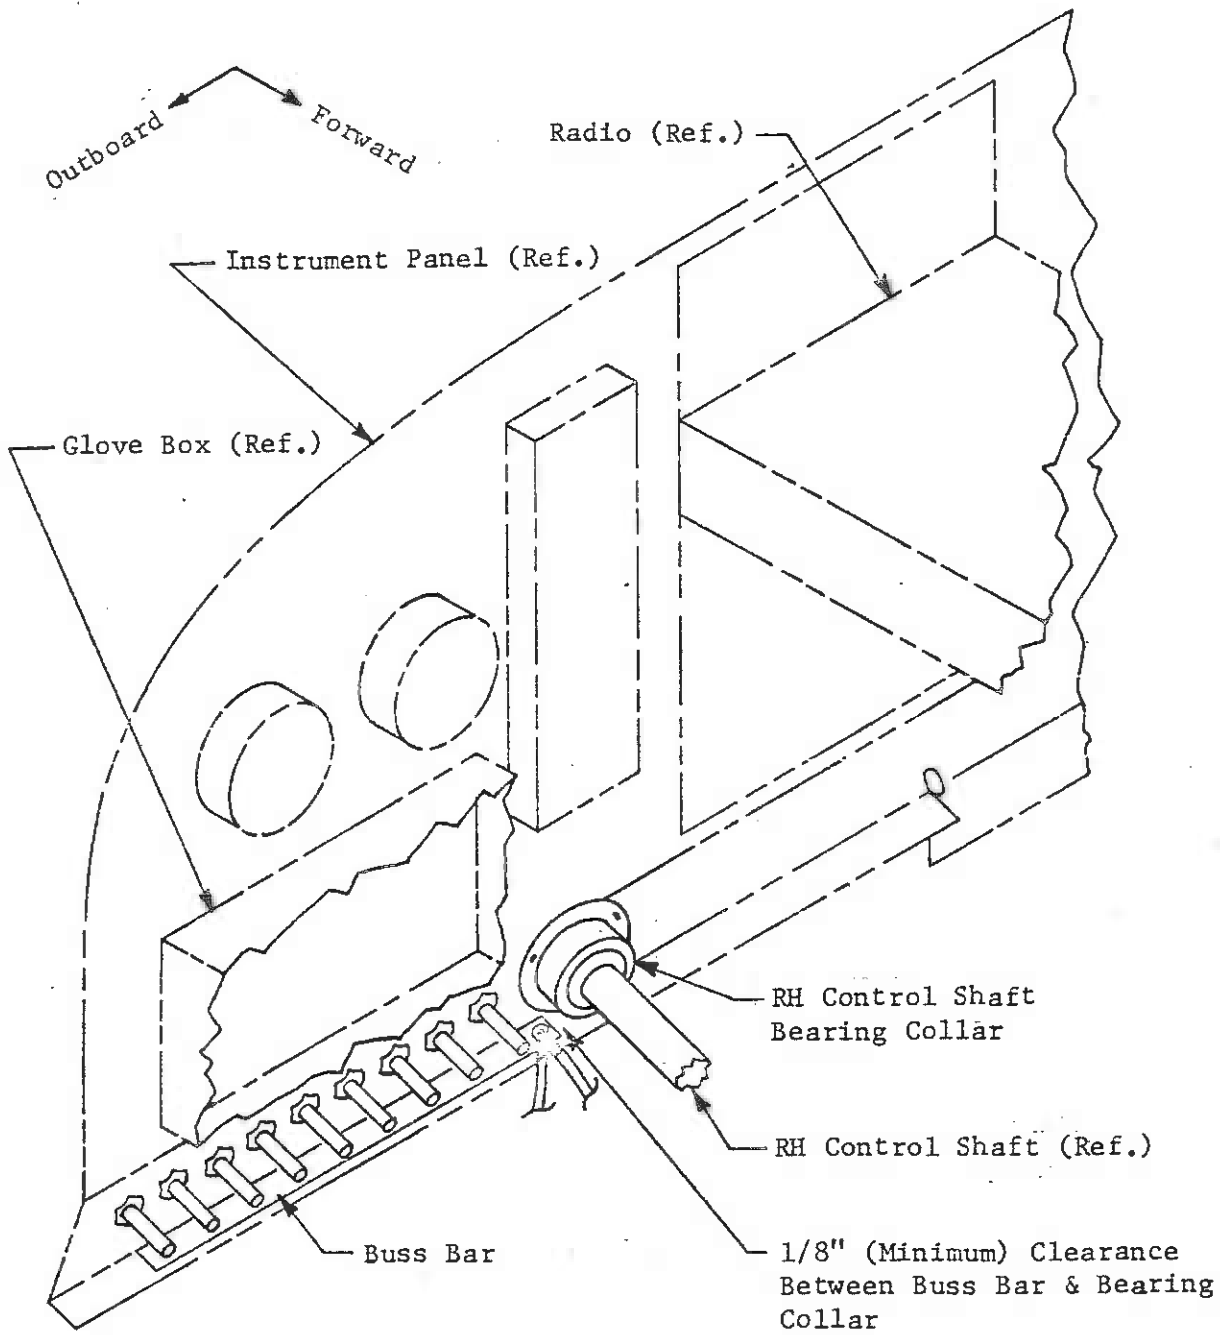
Figure 1. Buss Bar/Bearing Collar Clearance

To preclude the possibility of inadvertent grounding of the electrical system, due to deflecting or bending of the buss bar, a recent production change has increased the clearance between the buss bar and the right hand control shaft bearing collar.

The minimum clearance between the buss bar and the right hand control shaft bearing collar is 1/8" (See Figure 1). This clearance may be checked as follows:

2. Remove the right hand control wheel shaft.
3. Remove the right hand vent airbox by taking out the two plug buttons on the under side of the box and using a long Phillips screwdriver, remove the screws attaching the airbox to the instrument panel.
4. Bend or trim the inboard aft corner of the buss bar to obtain 1/8" clearance between buss bar and the right hand control shaft bearing collar (See Figure 1).

Avoid stressing the buss bar, as separation of the buss bar/fuse holder solder connections could occur.
