# SERVICE BULLETIN

**SB-193**

SUBJECT: AFT WING SPAR CORROSION

MODEL / SERIALS AFFECTED: AG-5B All

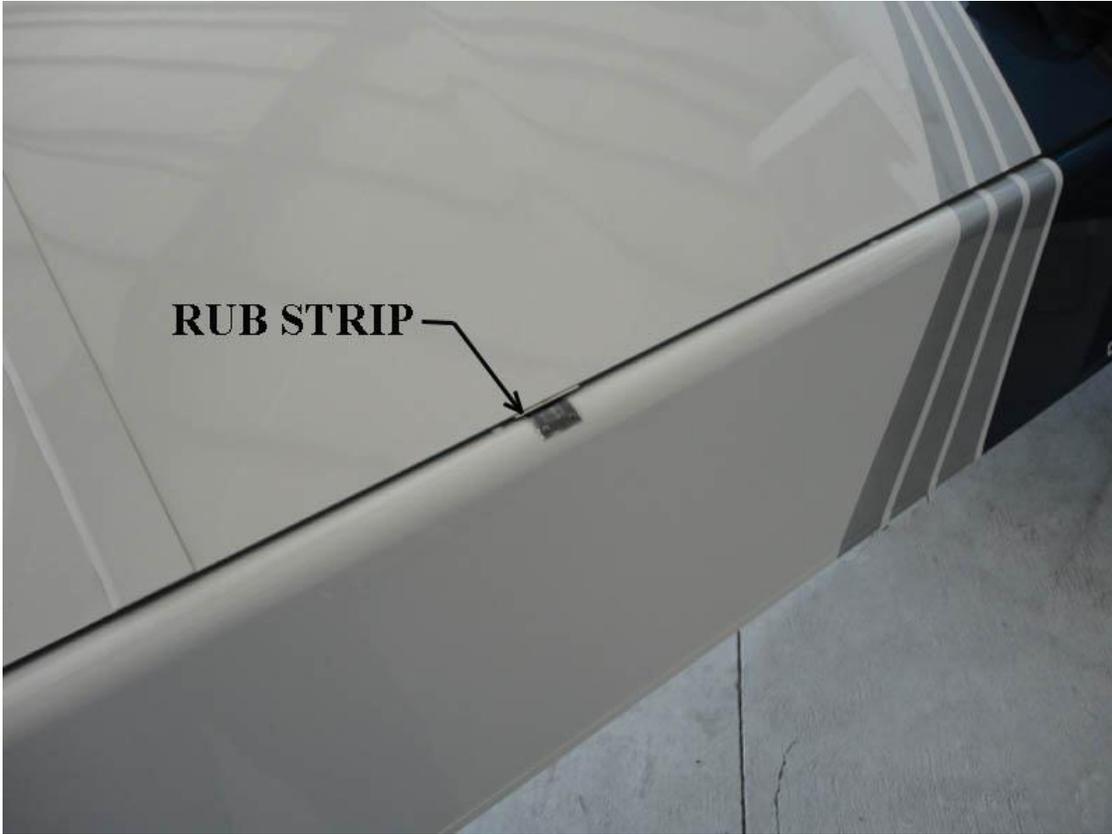
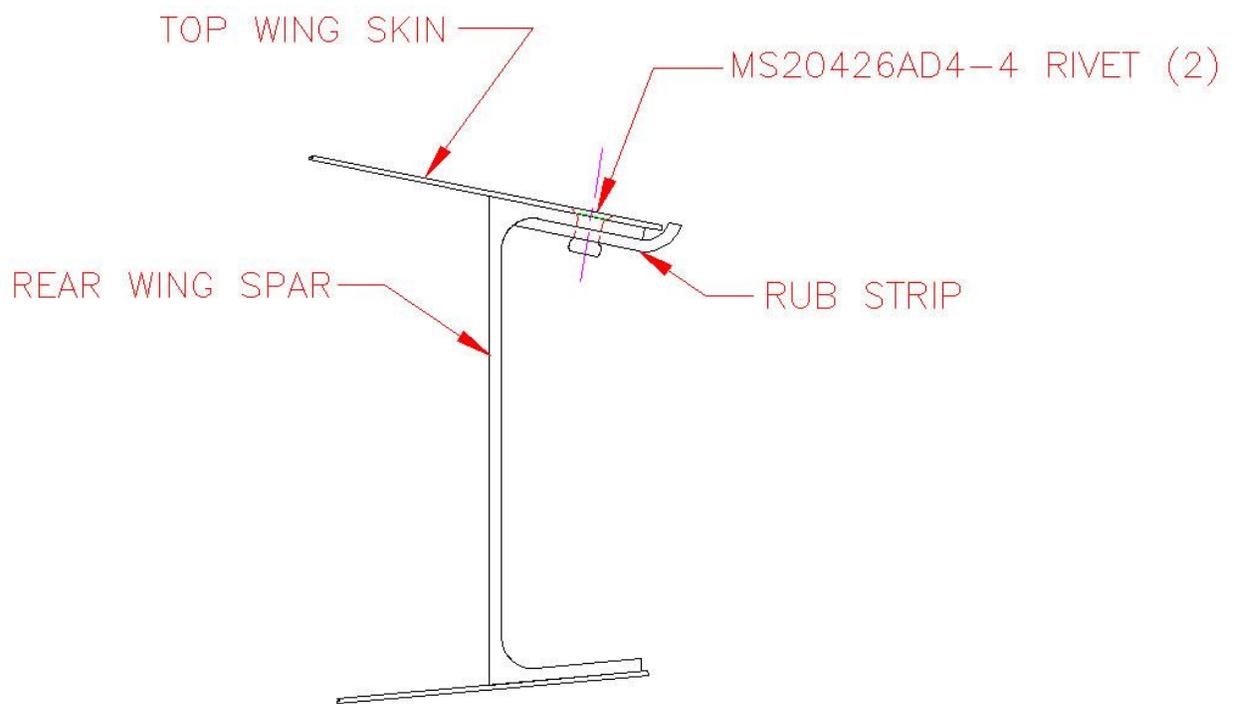
**FIGURE 1**

1. Remove the wing tip, aileron and flap. (See MM Chapter 27)
2. Drill out the two rivets that secure the Flap Rub Strip to the rear spar and remove the rub strip. (See Figure 1)

## **RUB STRIP LOCATION**

**Normal rub strip**

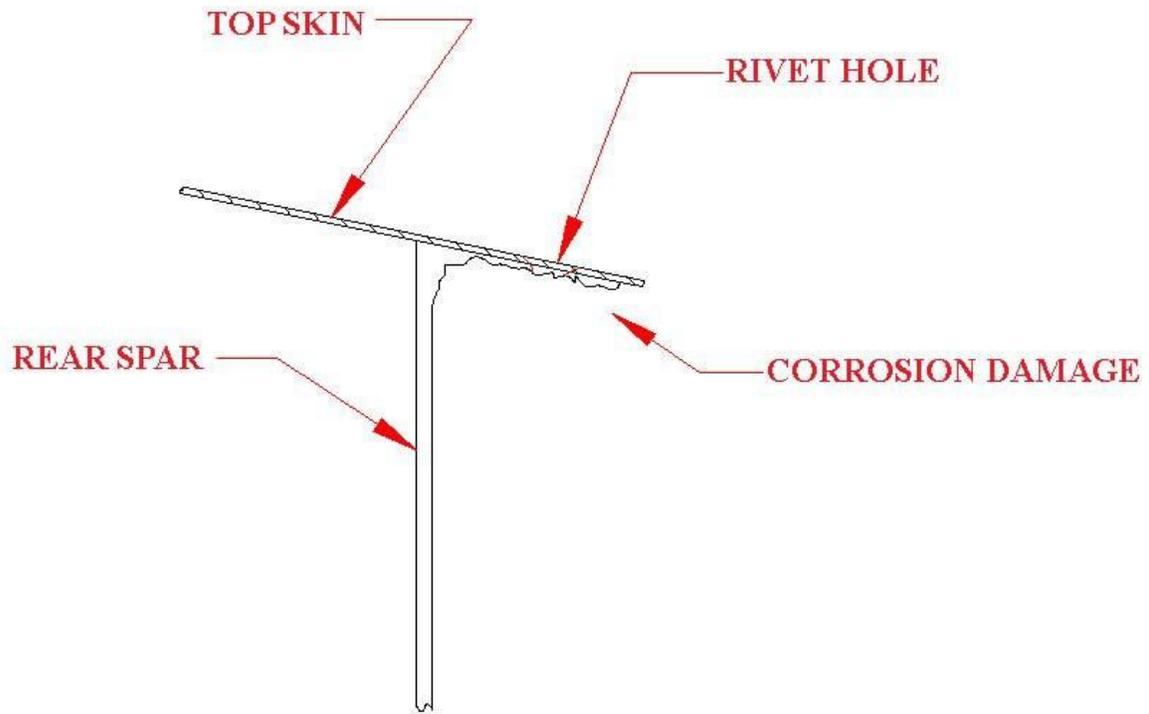
## FIGURE 2

3. Inspect the lower surface of the upper spar flange for evidence of corrosion such as a white, flakey ash in the area where the rub strip was attached and at a minimum, one inch from each side of the rub strip location. (See Figure 2)
4. Inspect the upper wing skin one inch forward and one inch from each side of the rub strip location for corrosion and bond line separation from the rear spar upper flange using the "Tap Test Method". (Ref. MM Chapter 5)
5. Inspect the rivet holes for corrosion.

**RUB STRIP AND RIVETS REMOVED**

- A. If no corrosion or minor corrosion (less than .005" deep) is found and there has been no wing skin bond line separation from the rear spar, accomplish the following:
  1. Remove all corrosion and clean the affected area of the wing.
  2. Clean and inspect the flap rub strip and replace if any corrosion is found.
  3. Prime the spar (including the inside of the rivet holes) and the mating surface of the rub strip with zinc chromate and allow to dry.
  4. Apply Polysulfide Sealant (i.e. PR1422-B2 or equivalent) to the mating surface and reinstall the rub strip. Install rivets wet with sealant. Fillet seal around the edges of the rub strip and paint as required.
  5. Reinstall the flap, aileron and wing tip in accordance with the Maintenance Manual, Chapter 27.
  6. Make an appropriate entry in aircraft log book.
  7. No further action is required.

- B. If corrosion is found to be in excess of .005" deep and /or if there is wing skin bond line separation from the rear spar accomplish the following:
  1. Comply with the instructions in Service Kit No. 157 "AFT WING SPAR CORROSION REPAIR".
  2. Make the appropriate aircraft log book entries.
  3. No further action is required.
