SUBJECT: Battery Box Cover Modification

SERIALS AFFECTED: AAL-0137 thru AAL-0457, AALA-0001 thru AALA-0132

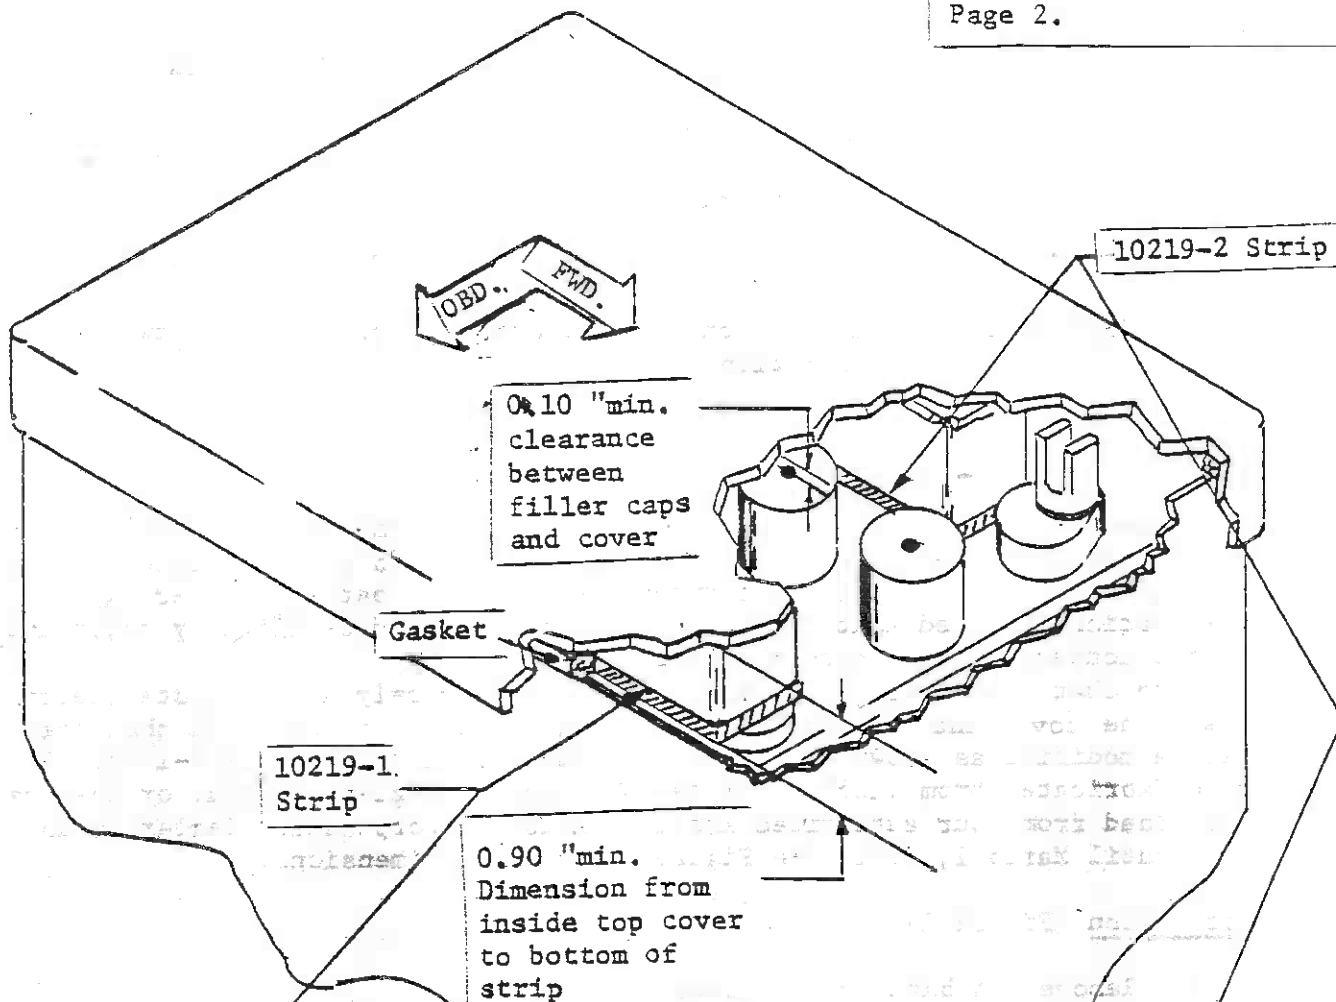
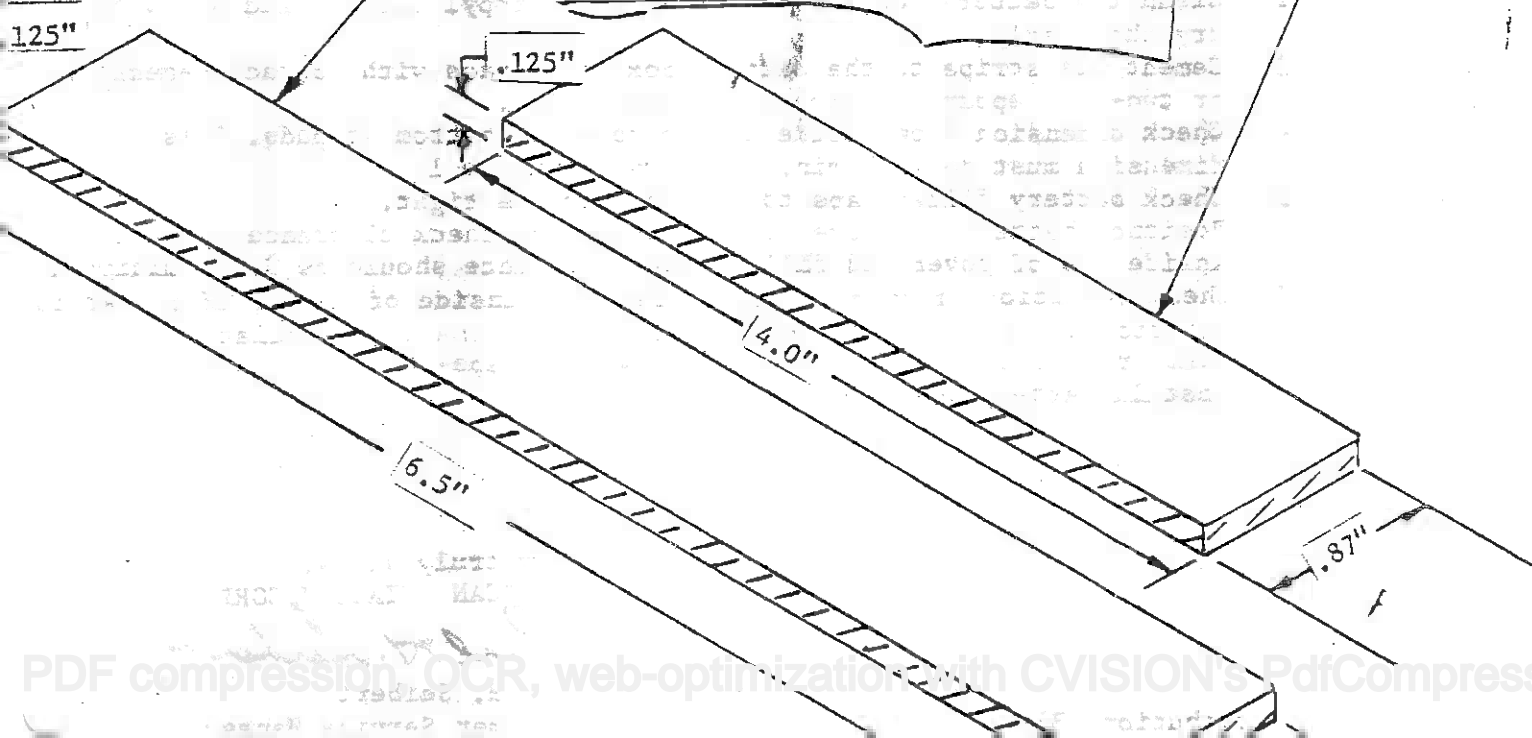
### Modification (Figure 1)

It has been noted on some aircraft in the field that the battery box cover may be distorted when the cover clamp is drawn down, and in other instances, inadequate clearance has been found between the cover and battery filler caps. Investigation revealed that the pads inside the cover were slightly short and were not contacting the battery properly.

To insure that the cover is holding the battery securely and adequate clearance between the cover and battery fill caps exists, it is recommended that the cover be modified as shown on Figure 1. Strips (Part Numbers 10219-1 and 10219-2) can be fabricated from .125" Royalite, Cyclocac, Plexiglas or wood, or they may be obtained from your authorized American Aviation Corporation Dealer at no charge until March 1, 1972. See Figure 1 for strip dimensions.

1. Remove the battery box cover.
2. Clean the battery box cover pads with isopropyl alcohol and allow to dry thoroughly.
3. Cement the strips to the battery box cover pads with contact cement or two-part epoxy adhesive and allow to dry.
4. Check dimension from inside top of cover to bottom of pads. This dimension must be .90" min. as shown on Figure 1.
5. Check battery filler caps to assure they are tight.
6. Position battery box cover over battery and check clearance between inside top of cover and filler caps. Clearance should be 0.10" minimum.
7. Check condition of sponge rubber gasket on inside of cover. If gasket is deteriorated or does not contact battery box due to installation of strips, shim or replace with new gasket (#4104 Foam Tape-3M Co.).
8. Install battery box cover.
