American General Aircraft Corporation

CRITICAL SERVICE BULLETIN

SB-185

SUBJECT: **WING ATTACH SHOULDER BOLTS**

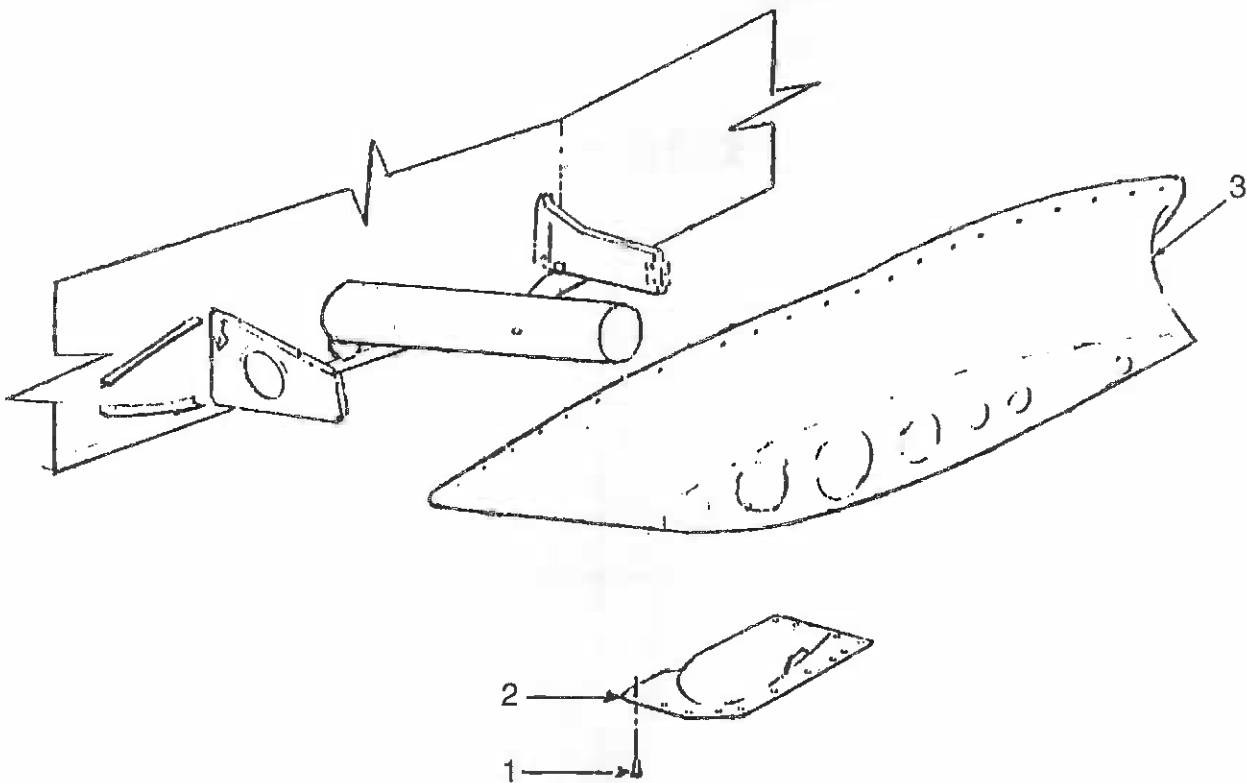
FIGURE 1

1. Screw
2. Access Panel
3. Wing Root

1. Prepare the aircraft for safe maintenance.
 - a. Disconnect the battery.
 - b. Connect the airframe to a suitable ground.
2. Remove the access panel from the lower wing root fairing (Figure 1).
3. From within the wing root, remove the (2) wing attach shoulder bolts (Figure 2) at each wing root main spar.
4. Inspect each of the four P/N 901044-3 wing attach shoulder bolts as follows:
